BEAM REPAIR PLAN

SH 51 NB OVER ARKANSAS RIVER		TULSA COUNTY	
Design	ADT	Detail	FEZ
Check	ADT	WHITE ENGINEERING ASSOCIATES	
STATE OF OKLAHOMA		DEPARTMENT OF TRANSPORTATION	
JOB PIECE NO. 31358(04)		SHEET NO. 32

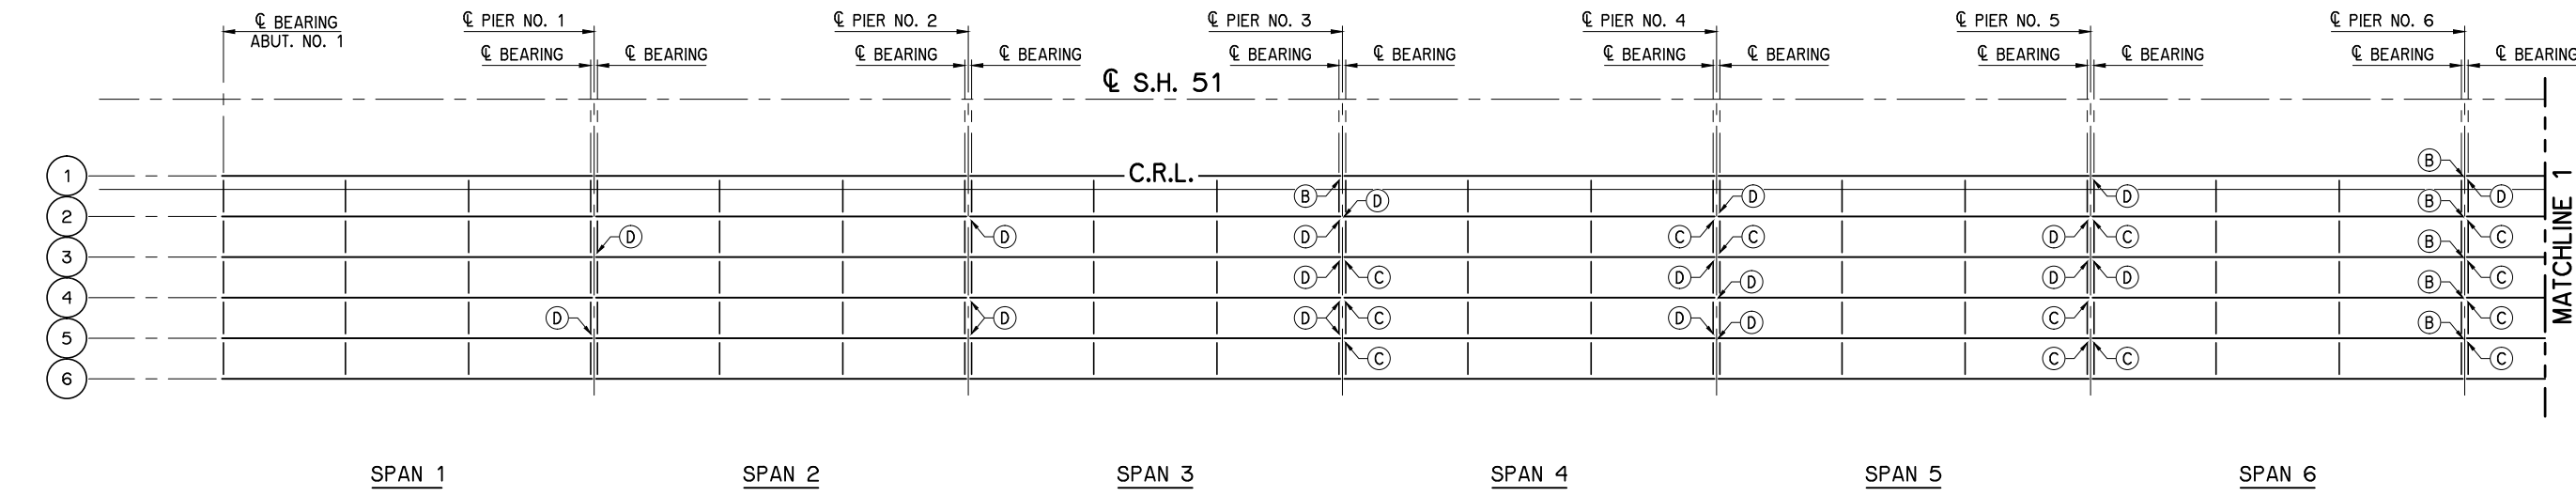
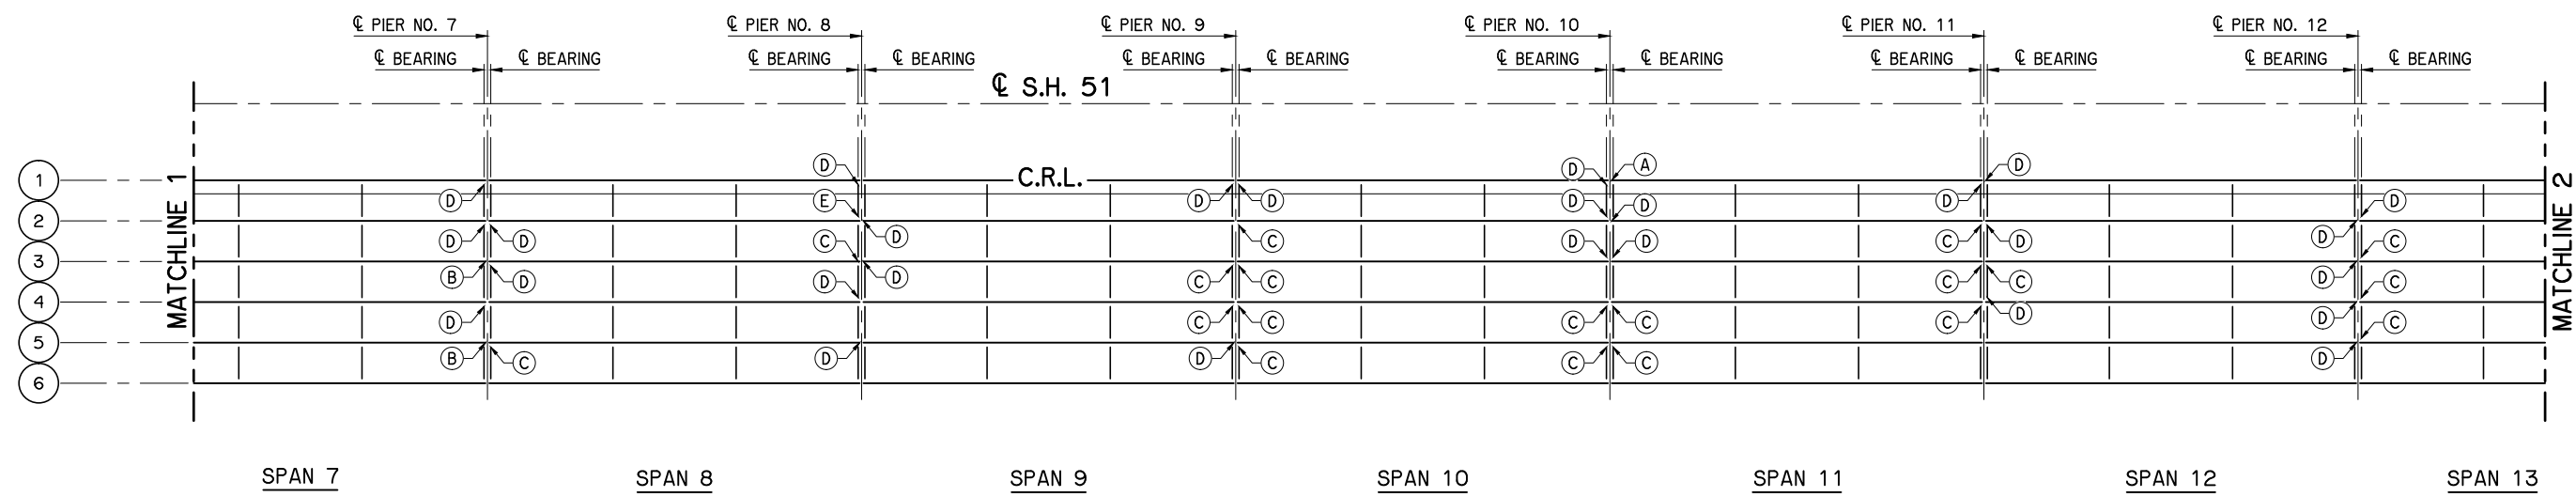
- (A) 4'-0" BEAM END REPAIR WITH CARBON FIBER-REINFORCED POLYMER WRAP AND CORROSION INHIBITOR AND 0.2 S.Y. DIAPHRAGM END REPAIR WITH PNEUMATICALLY PLACED MORTAR.
- (B) 3'-0" BEAM END REPAIR WITH CARBON FIBER-REINFORCED POLYMER WRAP AND CORROSION INHIBITOR AND 0.2 S.Y. DIAPHRAGM END REPAIR WITH PNEUMATICALLY PLACED MORTAR.
- (C) 3'-0" BEAM END REPAIR WITH CARBON FIBER-REINFORCED POLYMER WRAP AND CORROSION INHIBITOR AND 0.2 S.Y. DIAPHRAGM END REPAIR ON EACH SIDE OF BEAM WITH PNEUMATICALLY PLACED MORTAR.
- (D) 2'-0" BEAM END REPAIR WITH CARBON FIBER-REINFORCED POLYMER WRAP AND CORROSION INHIBITOR AND 0.1 S.Y. DIAPHRAGM END REPAIR WITH PNEUMATICALLY PLACED MORTAR.
- (E) 2'-0" BEAM END REPAIR WITH CARBON FIBER-REINFORCED POLYMER WRAP AND CORROSION INHIBITOR AND 0.1 S.Y. DIAPHRAGM END REPAIR ON EACH SIDE OF BEAM WITH PNEUMATICALLY PLACED MORTAR.

NOTES:
 FOR PNEUMATICALLY PLACED MORTAR DETAIL, SEE SHEET 27.
 FOR CARBON FIBER-REINFORCED POLYMER WRAP AND CORROSION INHIBITOR, SEE PRECAST BEAM DETAIL ON SHEET 33.
