PERFORMANCE OF ULTRA-THIN WHITETOPPING (UTW) IN OKLAHOMA

FINAL REPORT ~ FHWA-OK-10-05
ODOT SP&R ITEM NUMBER 2222

TYLER LEY
HARI ROTITHOR
OKLAHOMA STATE UNIVERSITY
CIVIL AND ENVIRONMENTAL ENGINEERING
207 ENGINEERING SOUTH
STILLWATER, OKLAHOMA 74078

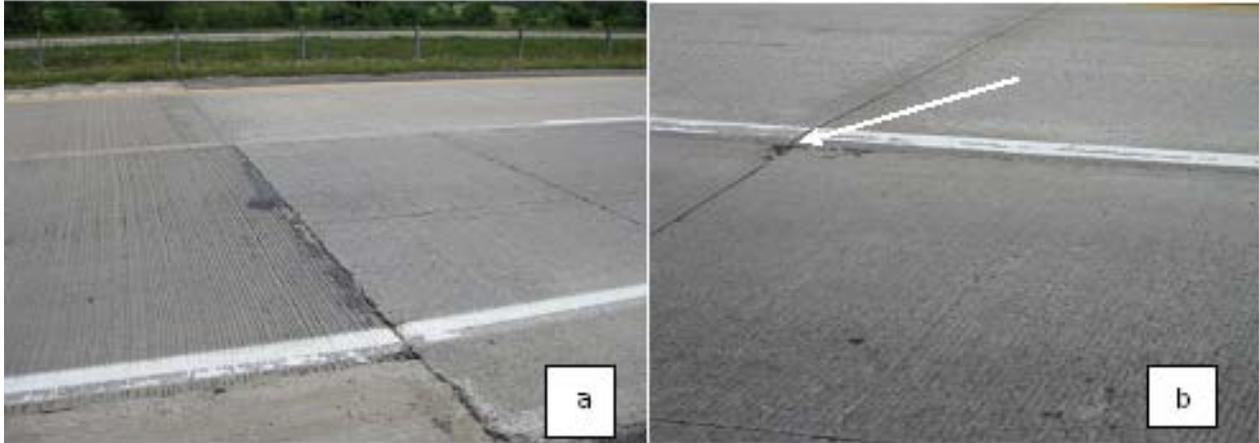
The overall condition of this overlay looks excellent. However, a few problems were observed. Joint raveling was a common problem which was observed as shown in Fig. 2.6 b. Some longitudinal cracks were seen covering multiple panels from 2 panels to 9 panels long. In total, 38 panels had visible cracks, which is about 1% of the total number of panels. Some examples of the longitudinal cracks are shown in Fig. 2.7. The passing lane was in better shape as compared to the driving lane. This is as anticipated as the travel lane would be expected to see significantly more traffic than the passing lane. Also in the driving lane the right wheel path showed more wear when compared to left wheel path. This may be due to the presence of an asphalt shoulder for this overlay. An asphalt shoulder would not provide as much support as the adjacent concrete lane. At about 0.2 miles from the start of the overlay a core was taken for previous testing. However, it was not refilled well; the filler material has been removed over time, as shown in Fig. 2.8. The drainage for this system was excellent.

Figure 2.6 - Photo a showing the start of the overlay at north end. Photo b shows typical joint raveling seen.

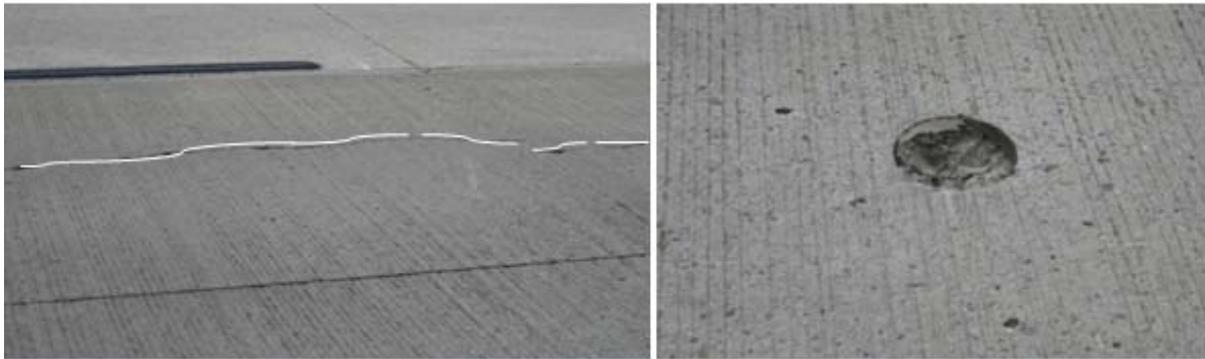
Figure 2.7 - Longitudinal Cracking spanning over panels

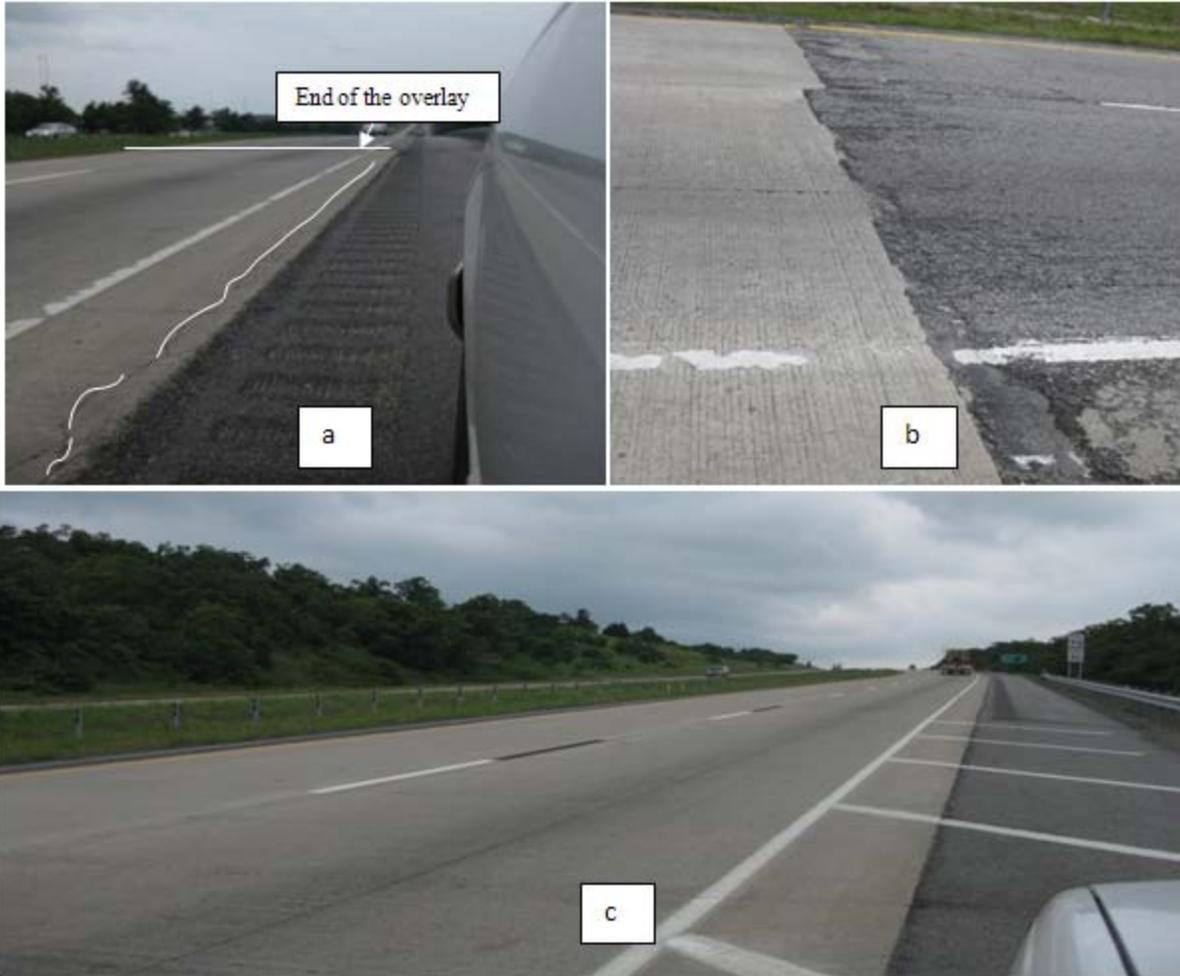
A longitudinal crack that covered 13 panels on the outside of the pavement was seen, as shown in Fig. 2.9 a. Faulting was seen at the end of the overlay. The last seven panels had problems with faulting. Occasional grinding on the surface was seen on these panels. This south bound overlay ended at an asphalt pavement as shown in Fig. 2.9 b. The end was also the top of a hill as shown in Fig. 2.9a.

Figure 2.9 - Photo a shows the 13 panel long longitudinal crack at the end of the overlay. Photo b shows the transition of concrete into asphalt at the end of the overlay. Photo c shows overall good condition of the overlay.

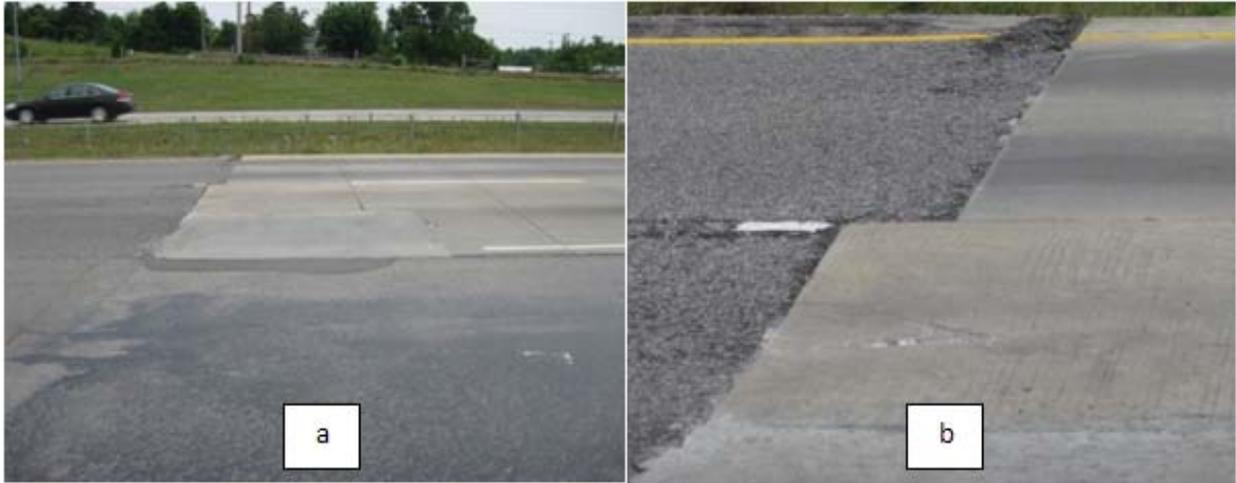
The overall condition of this overlay looked very good. However, there were some problems observed. The initial panels had been replaced with a new concrete panel (Fig. 2.10 a). A definite elevation difference was seen between the asphalt pavement and the approach thin white-topping panel at the beginning of the project. The elevation difference was very significant, with some cracking observed in the approach panels even after the replacement (Fig. 2.10 b). Some heavy polishing was seen in both driving and passing lanes of the overlay, stretching to over 30 panels in length. Longitudinal cracking was also seen, but it was insignificant as it was just at a couple of places over the overlay and also spanned only for two panels. At about 0.7 miles after the start of the overlay (at exit for US 270 west on the highway), two punch outs were seen, as shown in Fig. 2.11. Some corner cracking was also observed where the approach ramp meets the overlay after this exit. None of the problems stated above were extensive, but they should be monitored for future deterioration. The end of the overlay looked good without any sign of distress, as shown in Fig. 2.12, as it ends in a concrete bridge. Also, drainage of this overlay looked quite good and satisfactory.

Figure 2.10 - Initial panel replacement at the start of overlay as seen in photo a, and in photo b we see how there is an elevation difference between the leaving asphalt panel and approaching concrete panel.

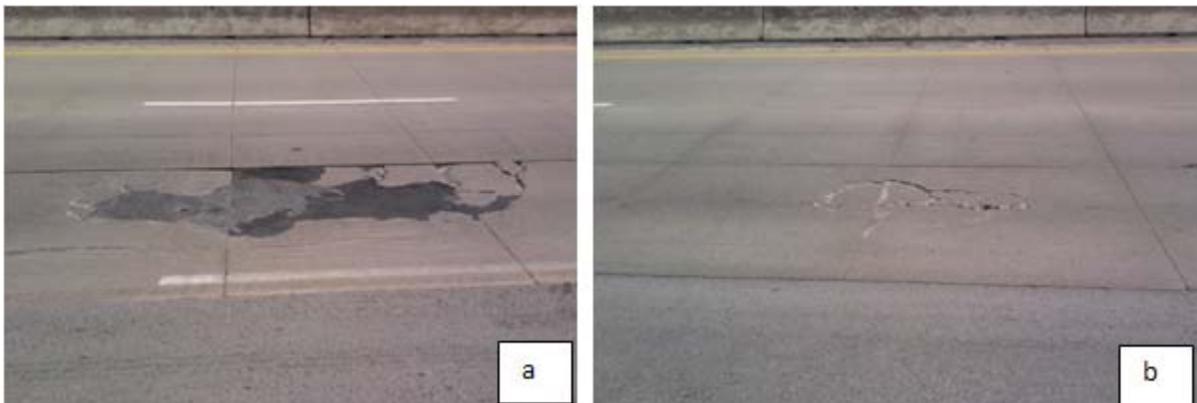
Figure 2.11 - Punch outs at the exit for US 270 west. These two punch (photos a and b) outs are about ten panels apart from each other.

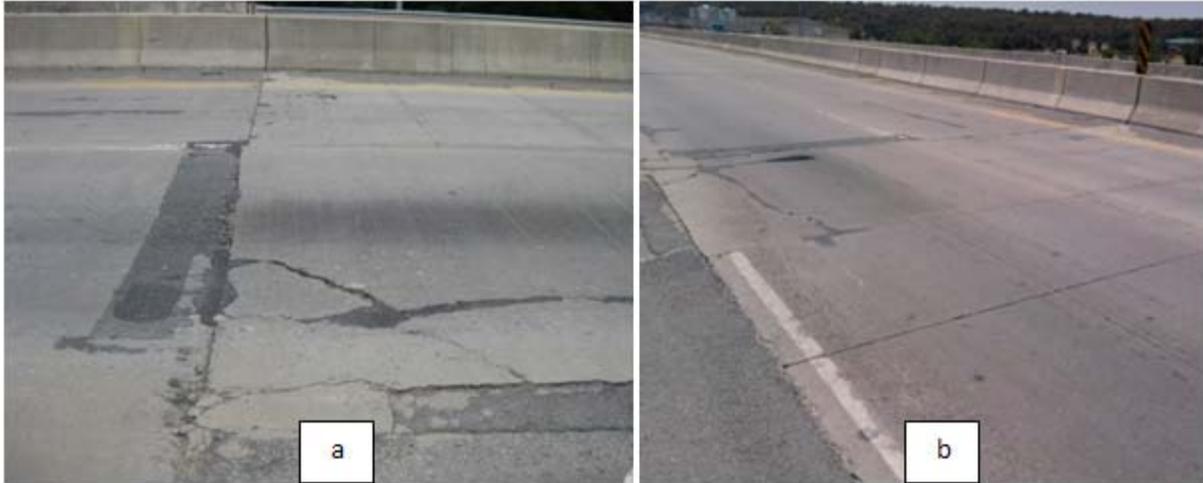
This overlay starts at the end of a concrete bridge in McAlester. The overlay has shown good performance apart from the initial panels. The initial panels have heavy block cracking, as shown in Fig. 2.13 a. The driving lane of the overlay has a continuous replacement panel and not the thin white-topping overlay seen in the passing lane, as shown in Fig. 2.13 b. The reason for these failed initial panels could not be determined. Some minor longitudinal cracking, scaling and polishing were observed in the passing lane. However, they probably are caused by normal wear. At about 0.2 miles from the south end of the overlay, heavy surface scaling and corner cracks were observed in the driving lane. Similar heavy abrasion and scaling was again observed in the passing lane about 0.8 miles from the south end of the overlay.

Figure 2.13 - Initial panels facing block cracking as shown in photo a. The first panel is replaced after initial failures with a full size panel as shown in photo b.

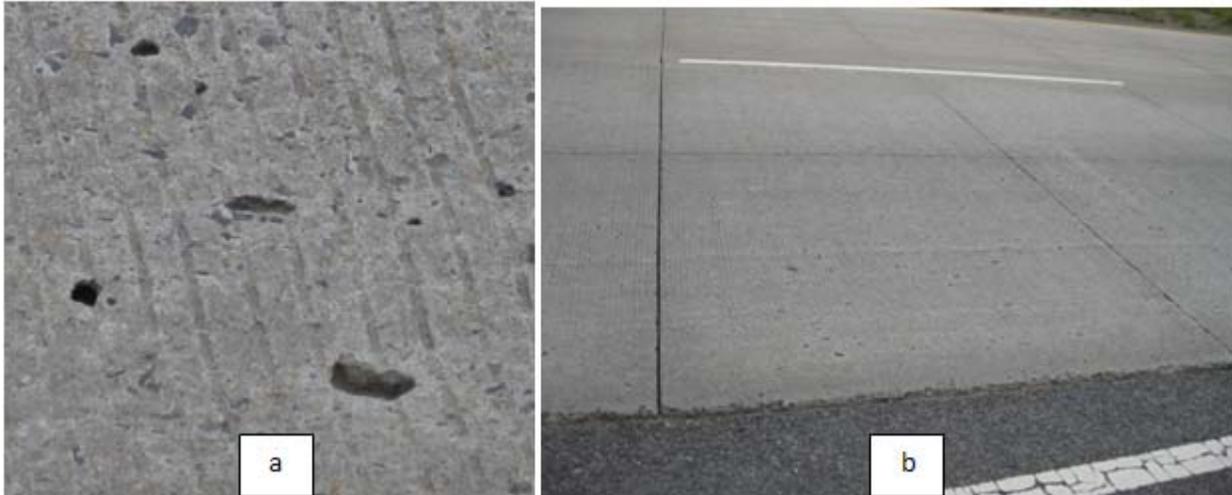
Some pop outs were seen about 0.5 miles from the south end of the overlay. About 24 panels showed pop outs with approximately 20 per panel, as shown in Fig. 2.14. This is likely caused by an unsound aggregate being used in these panels. The overlay ended in a jointed concrete pavement. Significant scaling and faulting were observed where the overlay ends. However, repairs have been done for both panels, as shown in Fig. 2.15.

Figure 2.14 - Photo a showing pop outs (about 20 pop outs/panel) of larger aggregates (on about 24 panels) at about 0.5 miles from the south end of the overlay. Photo b is just the closer view of photo a.

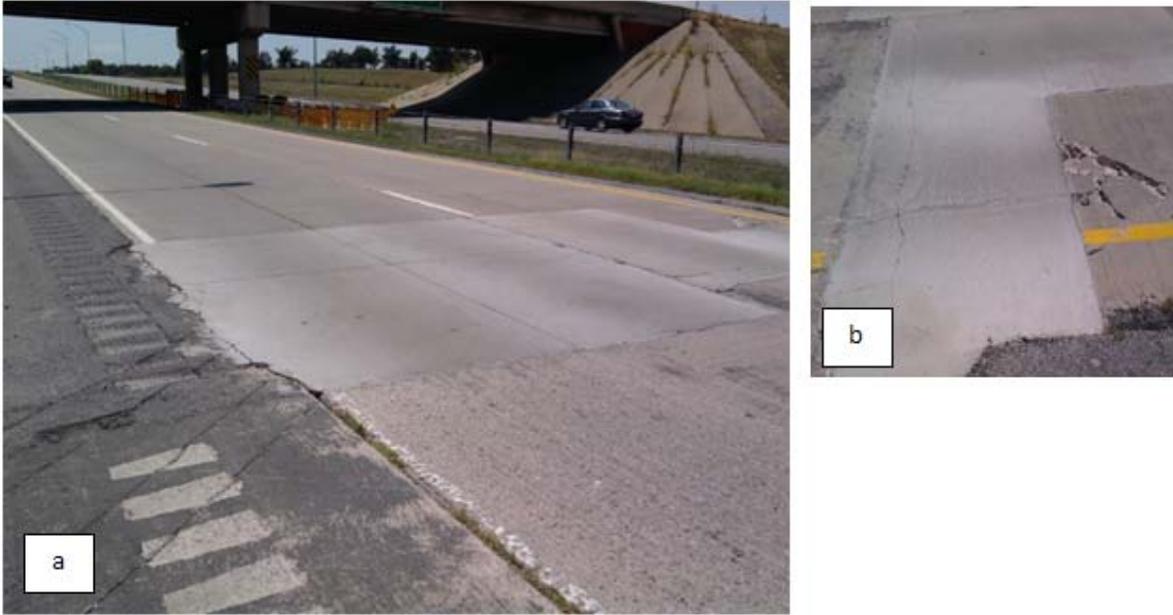
Figure 2.15 – Photo a shows the repaired panels at the north end of the overlay. Photo b shows a cracked panel at the west end of the overlay.

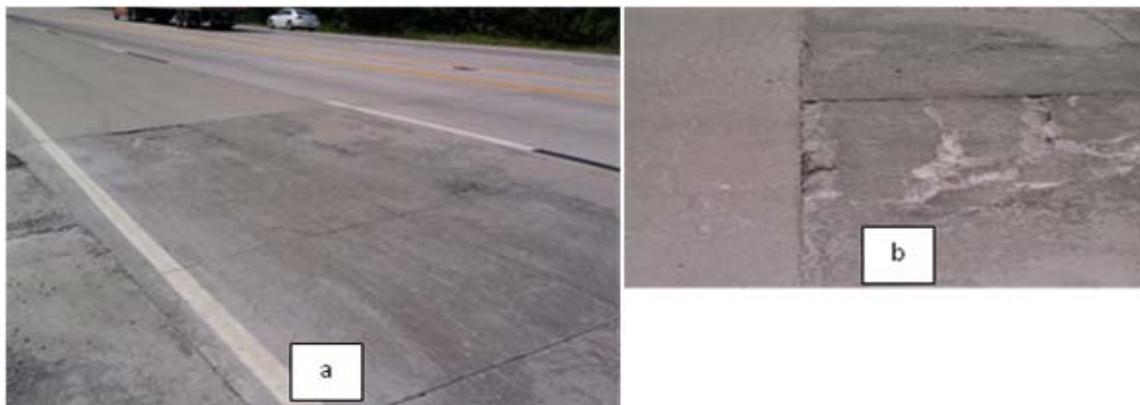
Figure 2.17 shows the start of the north bound overlay. The initial panel has block cracking, as shown in the photo. The reason for this block cracking could not be determined. This is surprising, as the overlay is just one year old.

Figure 2.17 – Photo a shows a cracked panel at the start of an overlay. Photo b shows a closer view of that panel.

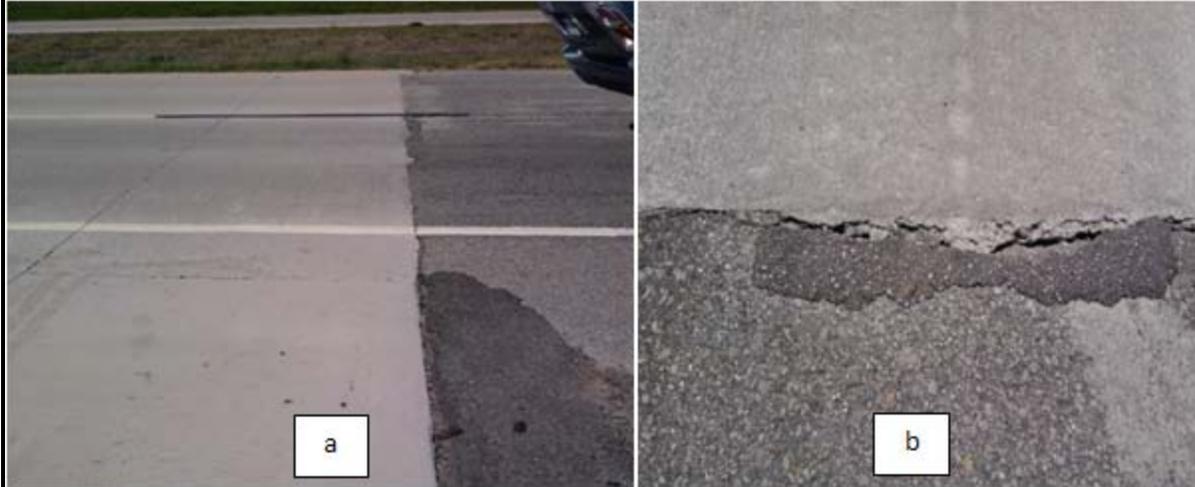
Figure 2.18 - Photo a shows the end of the overlay. The asphalt pavement looks good where it starts. But there is bit of distress initiation as shown in photo b.

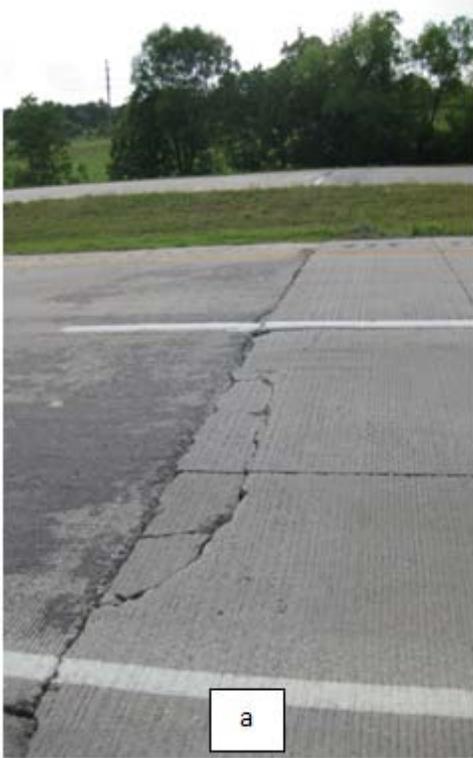
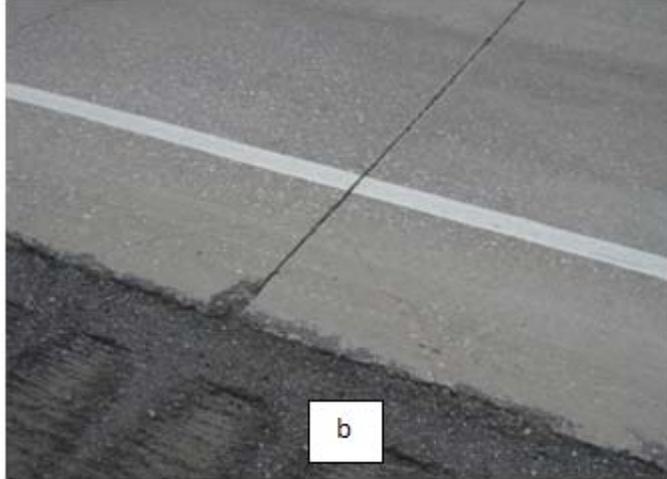
This overlay showed some distress where it was adjacent to a CRCP. This distress included corner cracking and some initial cracking at the interface between the two systems, as shown in Fig. 2.19 a and b. But all of those remain at a very rudimentary level and pose no issue of concern. The overlay otherwise was in good shape. The end of the overlay is shown in Fig. 2.20. Some polishing was seen in the intermediate stage of the overlay, but it looked like mechanical polishing done for smoothing the surface and not the wear of the overlay. Fig. 2.21 shows one of these areas.

Figure 2.19 – Photo a shows the cracked panels at the junction of the overlay and the existing asphalt pavement. Photo b shows a rare corner crack on the overlay.

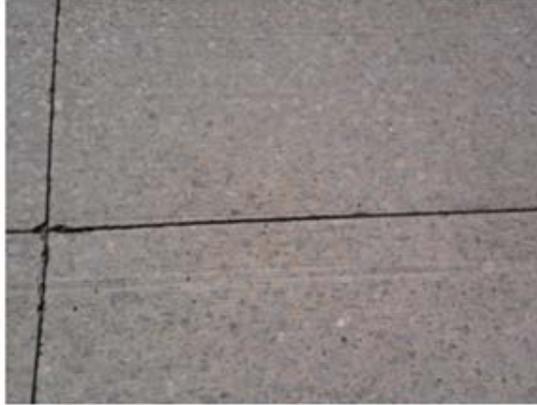
Figure 2.21 – Polishing of the overlay surface.

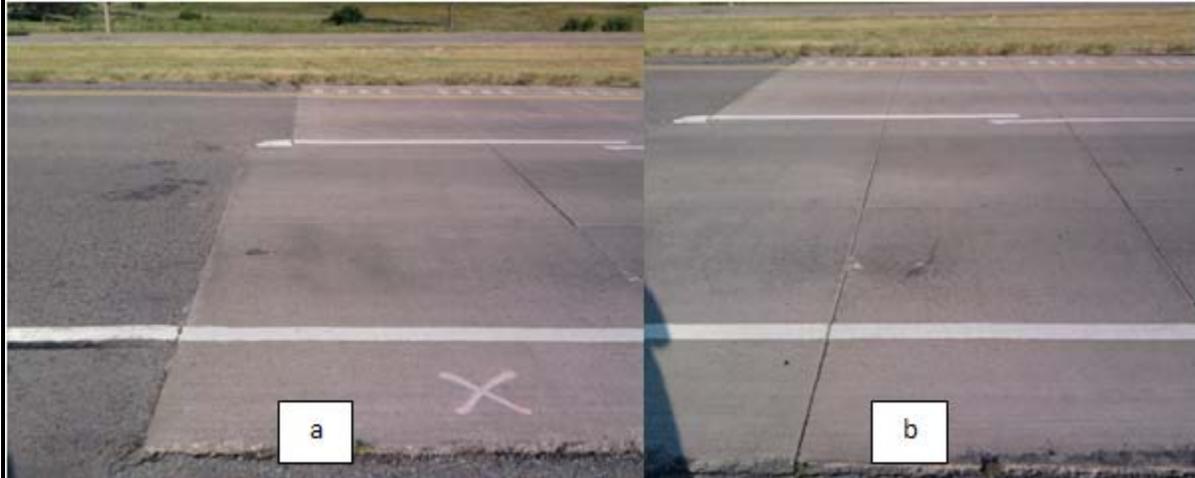
There was very few corner or longitudinal cracks seen on the pavement. Some polishing in the driving lane and some abrasion were seen in a few spots. Grinding was performed at some places to make the surface of the overlay smoother. The initial panel is without any distress, as shown in Fig. 2.22 a. There was some shoulder alligator cracking as shown in Fig. 2.23 a, but it was only seen at two places. The end of the overlay looked excellent, as it ended into a CRCP. The overall health of the overlay is excellent.

Figure 2.22 - Photo a showing start of the overlay where the asphalt pavement ends. A corner crack was seen on the second panel right after the start of the overlay is shown in photo b.

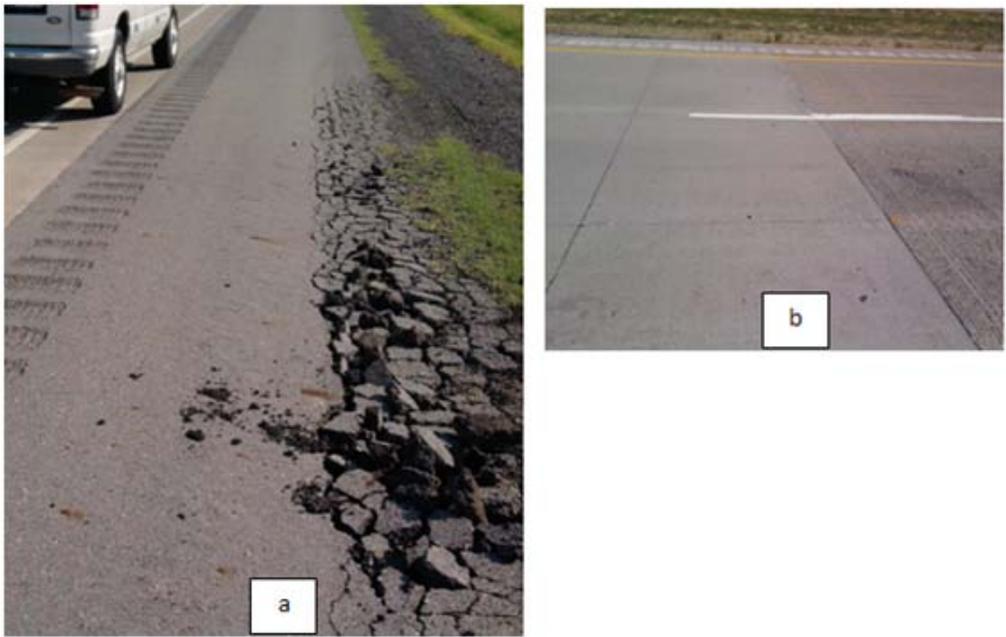
Figure 2.23 – Photo a shows the deterioration of the asphalt shoulders. Photo b shows the interface of the overlay with a CRCP pavement. The end of the overlay was in excellent condition.

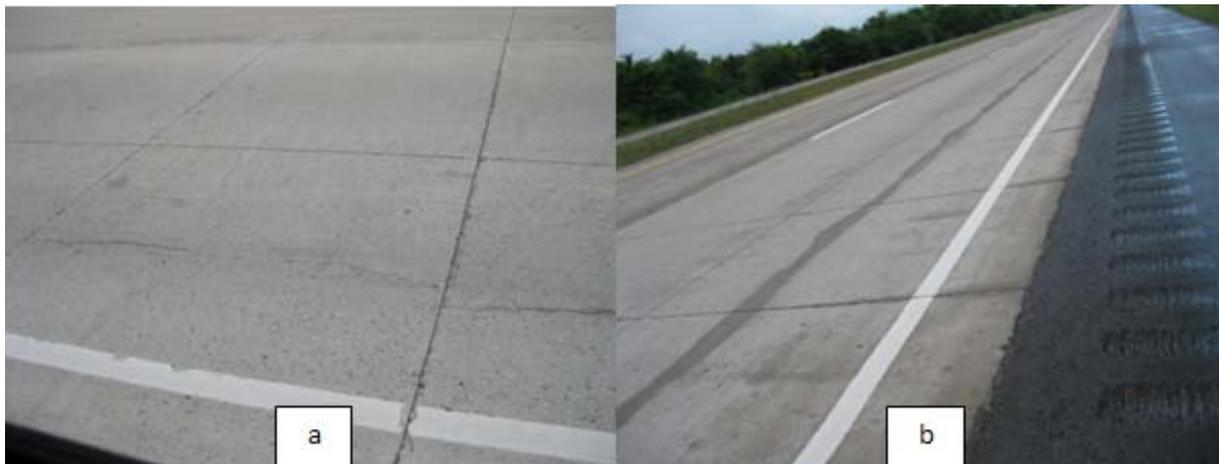
Most of the problems on this overlay were in the right wheel path of the driving lane. The passing lane did not show significant deterioration. Longitudinal cracks extending through two panels on average were seen all along the overlay; some cracks extended through up to 4 panels in a row. The number of cracked panels was significant, as shown in Fig. 2.24. About 200 panels (about 6%) were cracked per mile for the initial two miles. Then this crack pattern stopped abruptly.

Figure 2.24 - Photo a showing the type of longitudinal cracking pattern. Photo b shows the cracks after heavy rains overnight. The seepage of water through the cracks is clearly visible.

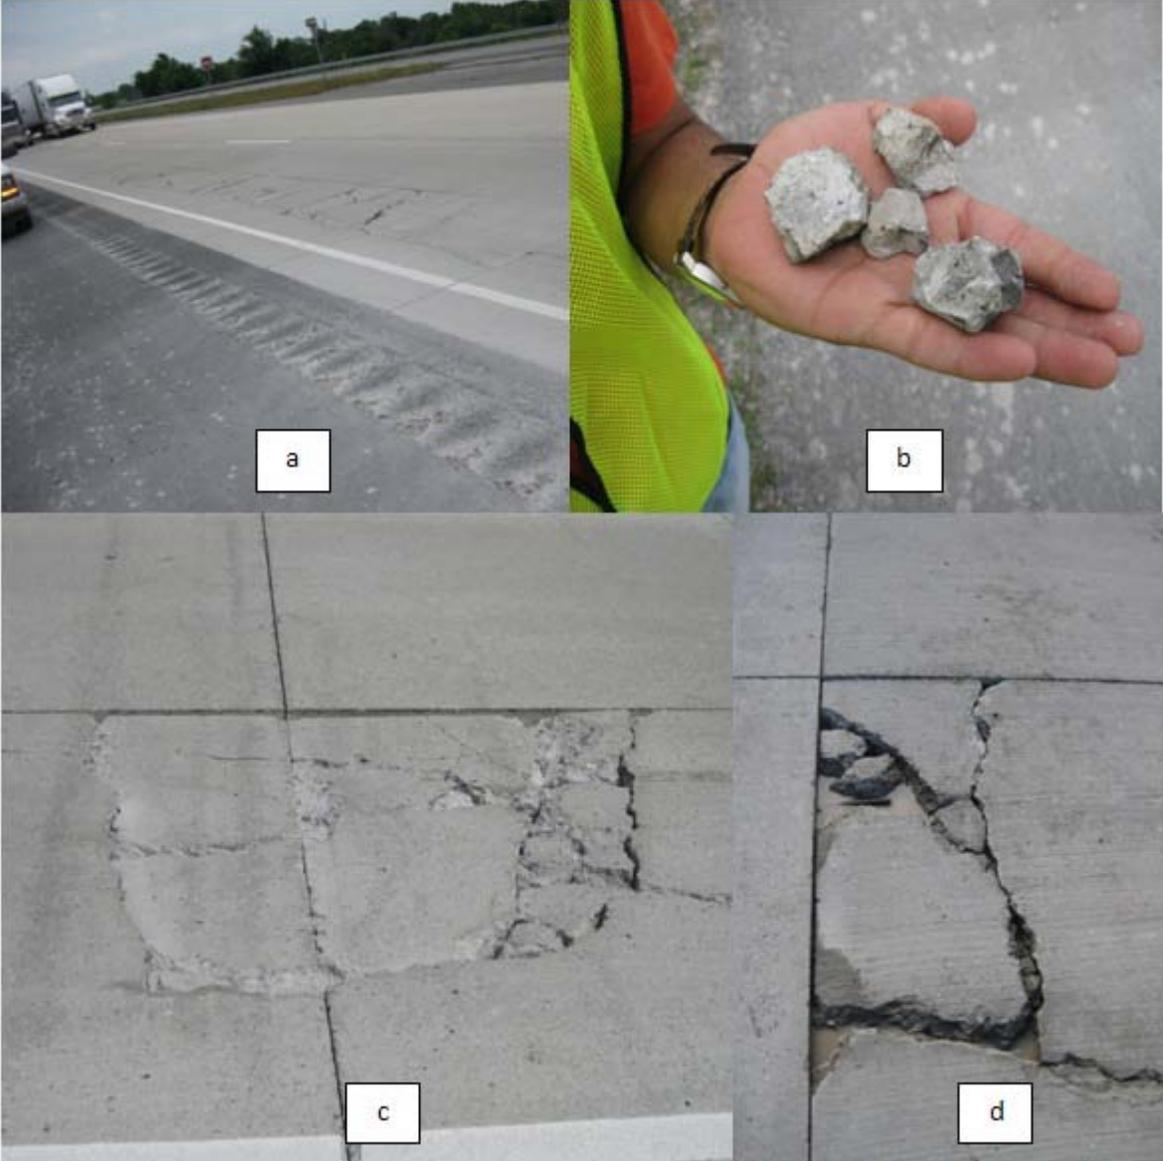
It was noticed that the deterioration of the overlay seemed to correlate with the intersections. Sometimes the failure was seen just as an individual panel failure. Sometimes it was seen as a series of panel failures covering up to seven panel failures in a single stretch. There were also large pieces of

concrete that were from the failed panels. The drainage for this overlay was not good. Several places were seen to retain water instead of letting it flow through the system. However, it is unclear how much of an effect this poor drainage has on the failures. A total of 19 such individual or series panel failures were seen along the 5 mile stretch of the overlay, some of them are shown in Fig. 2.25.

Figure 2.25 - Photos showing the failures of panels in the right wheel path of driving lane of the overlay. Photo a shows failures observed in continuous panels. Photo b shows the pieces of concrete that came from the failed panels. Photo c shows individual panel failures, typically seen in at the intersections. Photo d shows drainage problems in the pavement.

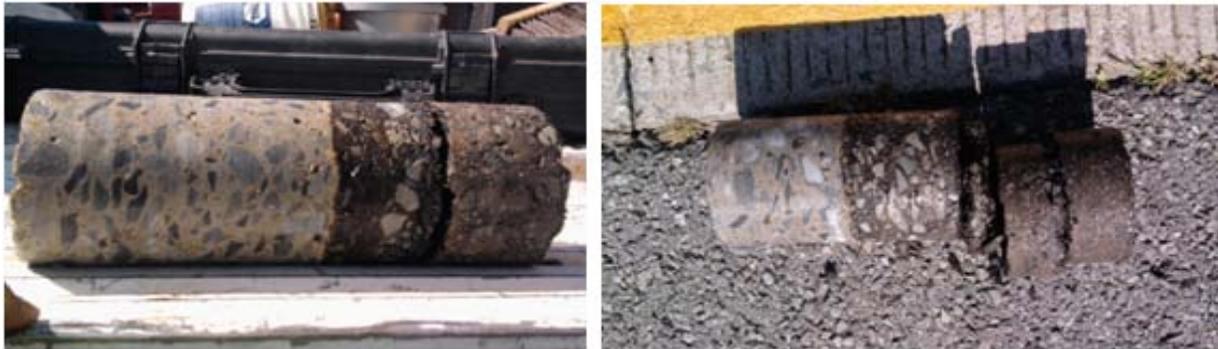
Fig. 2.26 shows the cores extracted from Oldest McAlester Whitetopping. The thickness of asphalt was found to be, at minimum, 9" and was on an average 11". This is likely one contributing factor into the positive performance of the overlay. Four cores were taken at the locations 1 and 5 from the driving lane and 3 and 7 from the passing lane as described in Table 2.9.

Figure 2.26 - Cores extracted on the oldest McAlester Overlay.

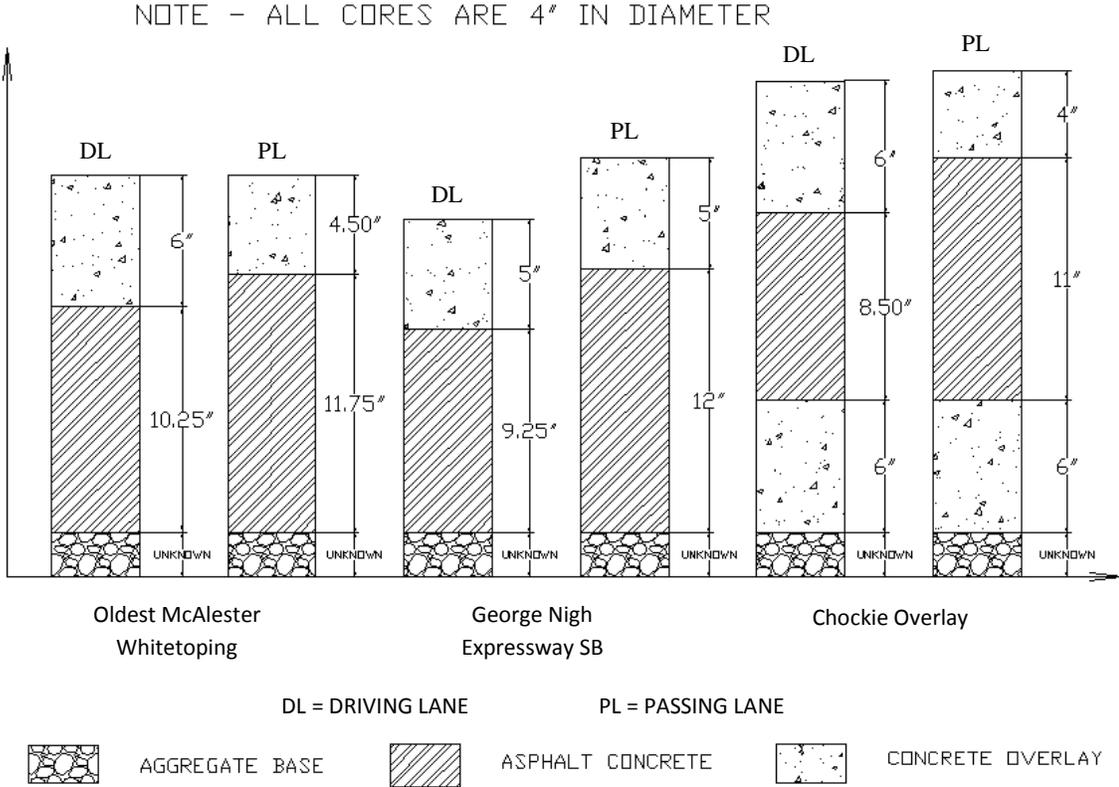
Figure 2.28 shows a comparison of the cores extracted from the overlays. As seen in the figure there is a difference between the overall depth of the material (concrete and asphalt) below each overlay. The George Nigh SB Whitetopping had the least amount of support material when compared to the other overlays but still shows satisfactory performance. It will be interesting to see how this material impacts the long term performance of this overlay compared to the others. The thickness of aggregate base is not included as the coring operations were only carried out from concrete overlay to the end of asphalt layer or to the end of the older concrete pavement for the Chockie Overlay.

Figure 2.28 - Details of different cores extracted from Overlay 1, Overlay 2 and Overlay 6 from left to right respectively. The values shown are an average of two core measurements.

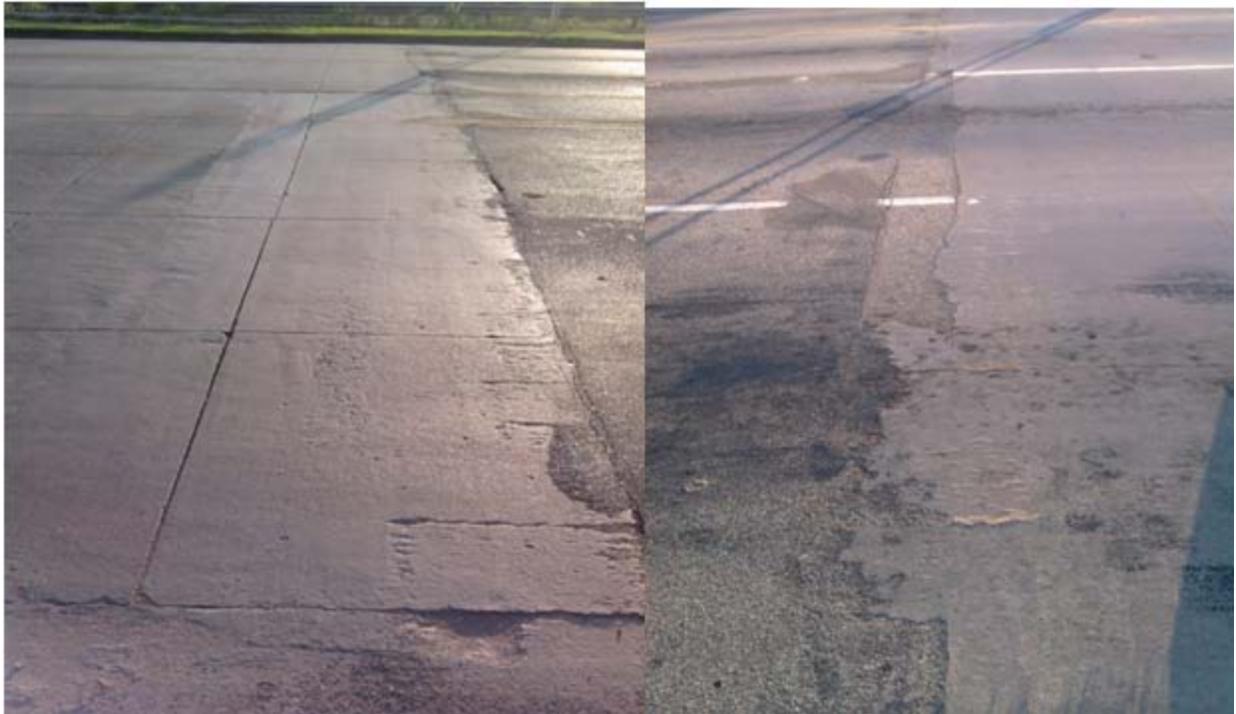
Figure 2.35 - Approach on US 177 from north showing absence in panel failures. Note the small difference in the elevation between the approach and leave pavements.

2. Maintaining close elevation difference at the approach panels may reduce the possibility of initial panel failures due to impact loading.

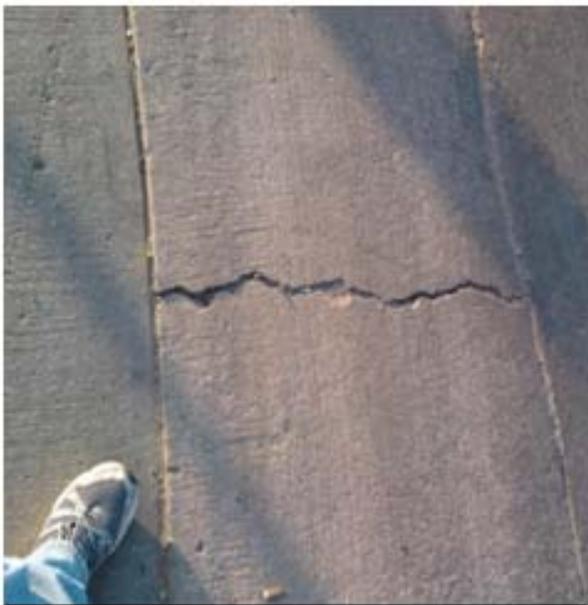
Figures 2.36 through 2.40 show the problems observed primarily at the west approach on SH – 51. The problems observed were cracking in the shoulder, approach panel failures, fines movements, and abutment cracking. Figure 2.36 shows the cracking in the shoulder on the US – 177 south side turn from west SH – 51. Figure 2.37 shows the approach panel failures from west SH – 51. The first panel is longer (6' x 9') than all of the other overlay panel dimensions. The 9' dimension is in the east-west direction, the same direction as the traffic. Also, there is considerable rutting (refer Fig. 2.37 b) on the adjacent concrete leave slab on the east side of the concrete bridge connecting to the intersection (refer Fig. 2.29 for layout of bridge and overlay). This rutting has induced an elevation difference which may have decreased the performance of the approach panel. In addition, since this panel is longer, one would expect the length to increase the bending stresses in the panel from center loadings as well as the curling of the panel. Severe cracking of the panel can be seen in Fig. 2.37.

Figure 2.36 – Distress cracking in the shoulder.

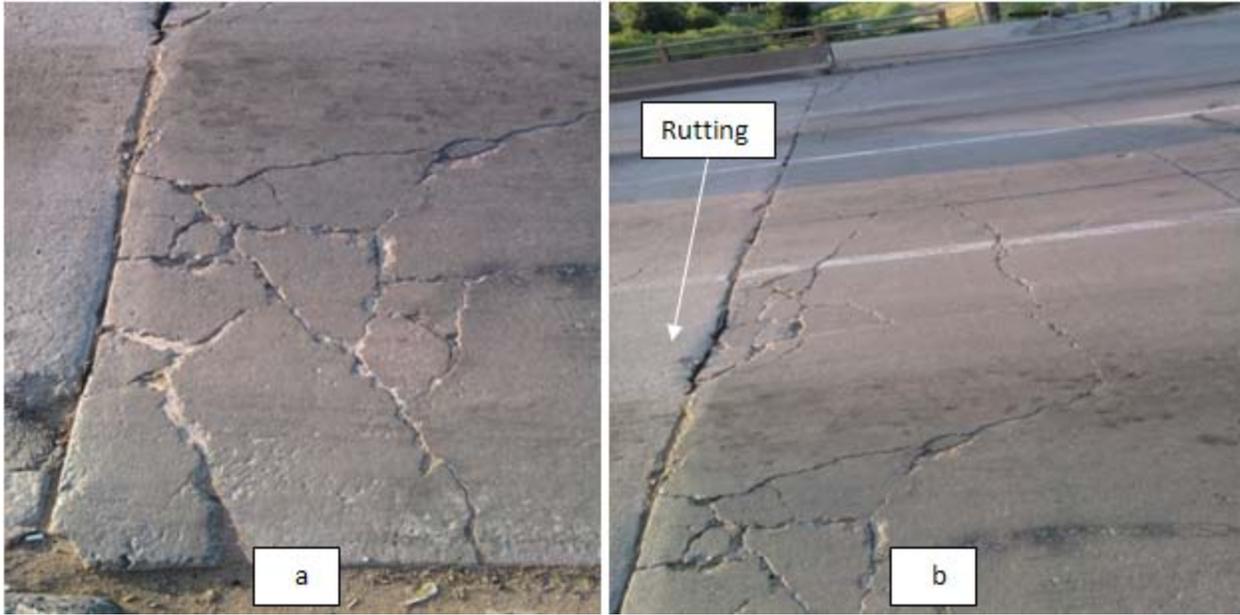
Figure 2.37 - Photos from west side of intersection on SH – 51. Photo a is at the intersection of the overlay and the concrete bridge. Rutting can be clearly seen in photo b.

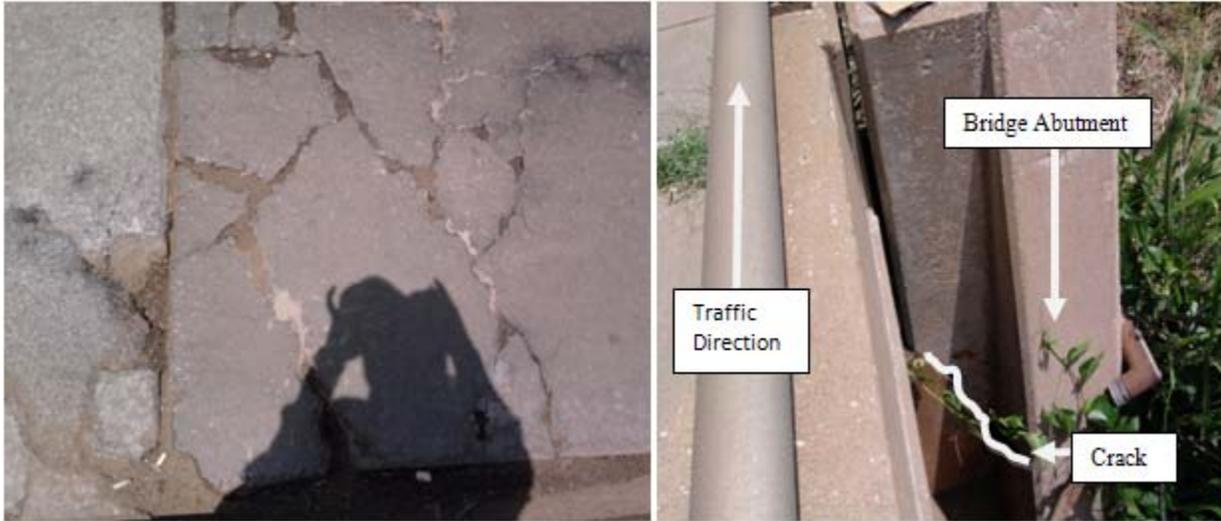
Figures 2.38, 2.39 and 2.40 show the fines movement seen on the pavements, the abutment cracking and the impact loading due to an insufficient turning radius for large trucks. Figure 2.39 shows the abutment cracking which may have been caused by thermal movements of the pavement or perhaps settlement of the compacted soil behind the bridge abutment. However, it is not clear when the cracking occurred. It is also not clear whether there is any type of relation between the fines movement and the bridge abutment. Figure 2.40 is really interesting as it shows how the tire impacts the ground as it leaves the curb and creates stresses on the surface of the pavement.

Figure 2.38 - Fines movement in first panels of intersection. **Figure 2.39** - Cracking in abutments of the bridge.

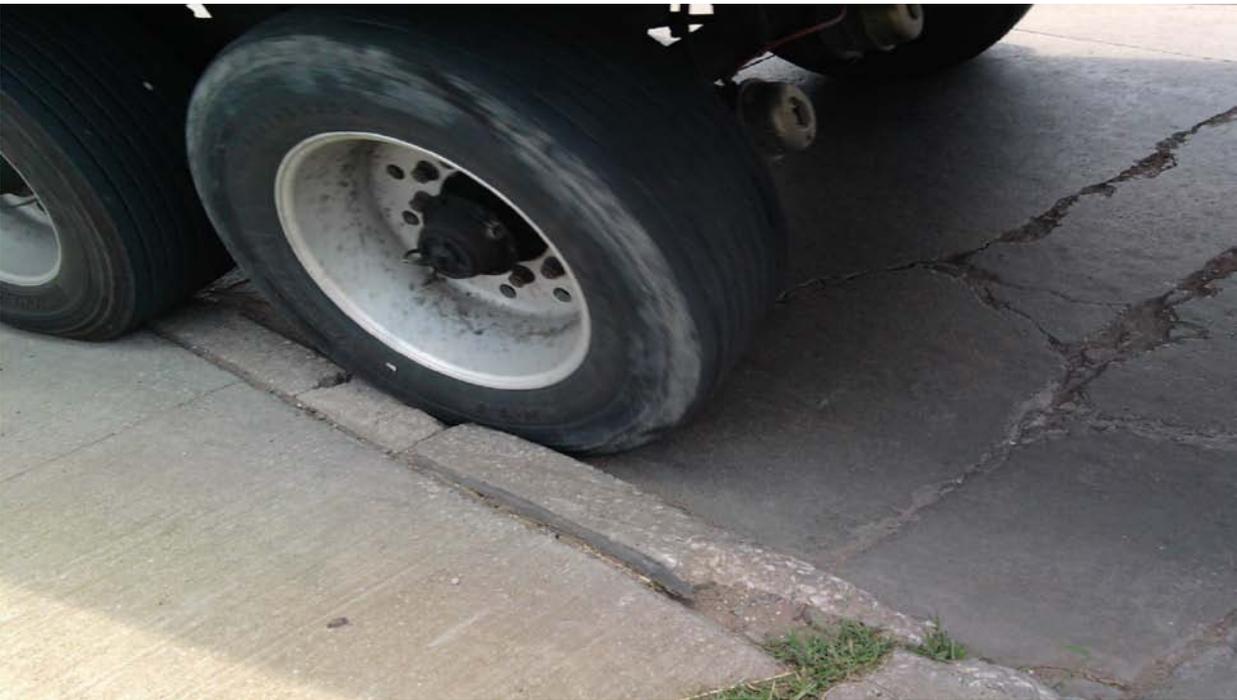
Figure 2.40 - Photo showing the impact loading due to lack of radius of curvature for large trucks.

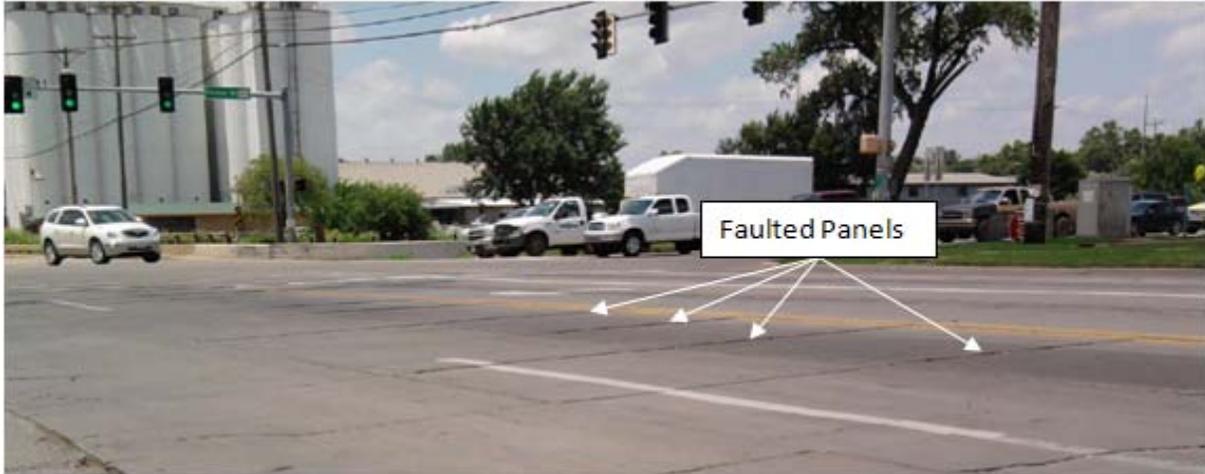
Figures 2.41 through 2.44 show the problems with the east end of the intersection. Again, this is also on SH – 51. Some of the problems observed were faulting and panel cracking where the concrete overlay interfaced the asphalt shoulder. Figures 2.41 through 2.42 show the faulting which is taking place on

the eastern end of the overlay. Predominantly, faulting was seen only in east bound lanes and not in west bound lanes. However, the west bound lanes showed quite a bit of longitudinal cracking.

Figure 2.41 - Photo showing faulting as seen from east end of the intersection. A repetitive noise was heard from the tires of the vehicles when they passed on the faulted panels.

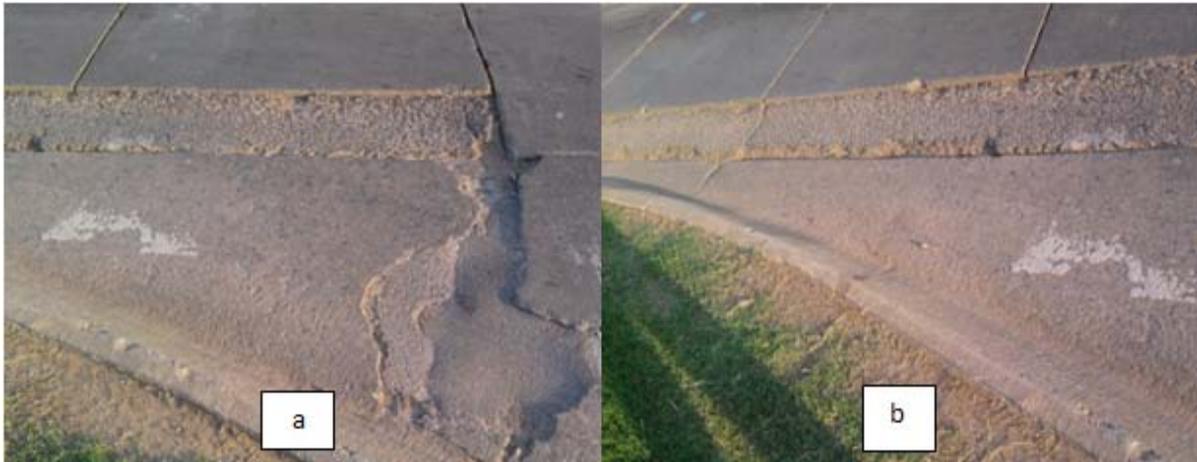
Figure 2.42 - Photos a and b showing faulting as overlay turns from west SH – 51 to north US – 177.

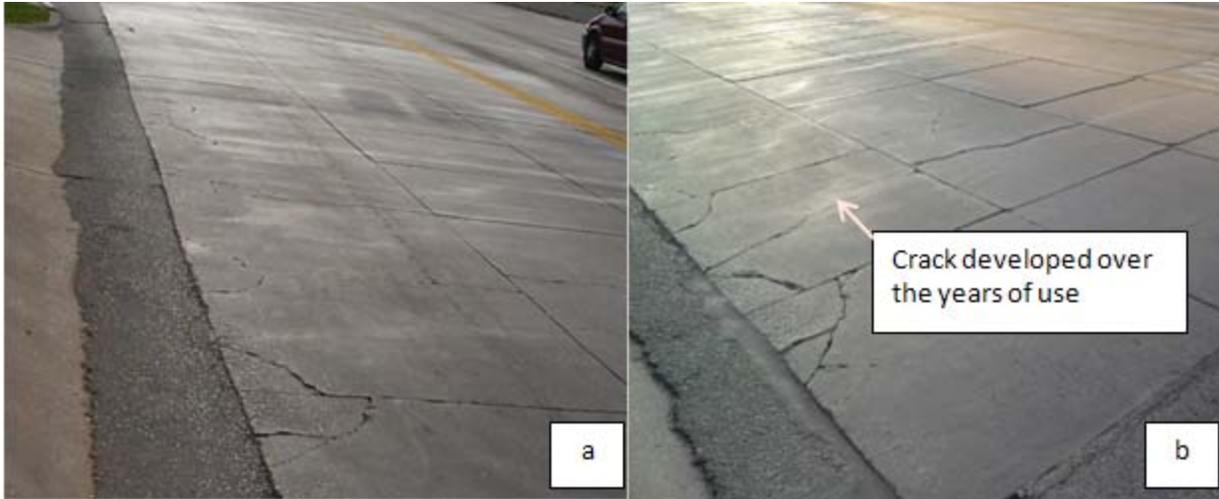
Figures 2.43 through 2.44 show how the cracking has increased. This increase in damage is apparent at the interface of concrete and asphalt. Figure 2.43 shows a crack that has extended from the shoulder since 2004. We know this crack has extended as we have photographs taken by MacArthur and Associates from 2004. Some sections were seen in which some parts of panels have been elevated, as shown in Fig.2.44.

Figure 2.43 - Photos at the entrance to the gas station showing how the cracking has changed between 2004 and 2010. Photo a was taken in 2004 (David Cline, MacArthur Associated Consultants) and photo b is taken by the research team in 2010.

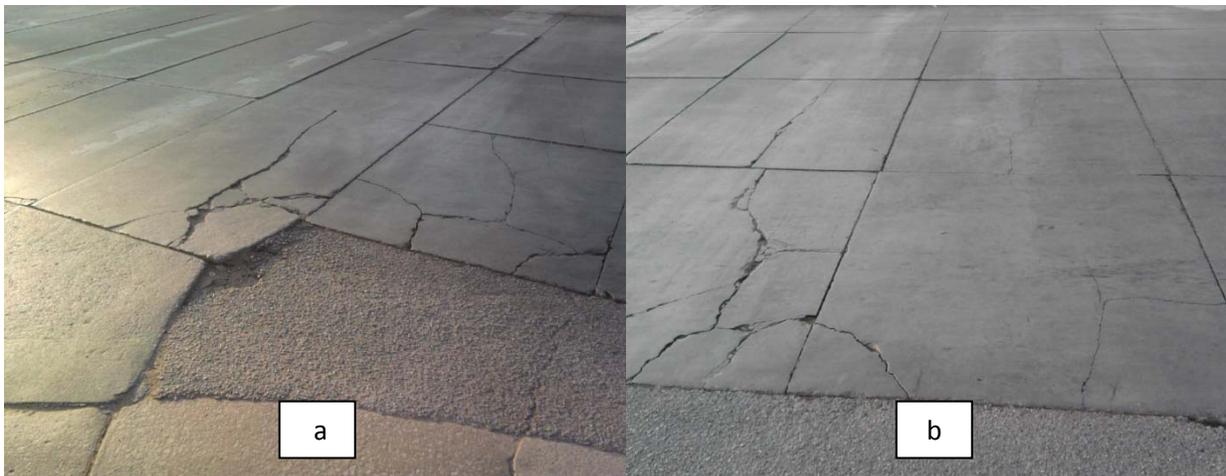
Figure 2.44 - Large block cracking at the east end of the intersection where the overlay is adjacent to the gas stations. The shadows shown in photo a show the difference in height between to the overlay and the adjacent asphalt. Additional block cracking can be seen in photo b.
