**Rating Precast Prestressed Concrete Bridges for Shear**  
**FINAL REPORT FHWA-OK-08-08**  
ODOT SPR ITEM 2186

1. REPORT NO. <b>FHWA-OK-08-08</b>	2. GOVERNMENT ACCESSION NO.	3. RECIPIENT'S CATALOG NO.	
4. TITLE AND SUBTITLE <b>Rating Precast Prestressed Concrete Bridges for Shear</b>		5. REPORT DATE <b>December 2008</b>

17. KEY WORDS <b>Prestressed Concrete, Shear Capacity, Quart-Point Rule, Code Comparison, Testing &amp; Inverse Problem of Aging Girder</b>		18. DISTRIBUTION STATEMENT <b>No restrictions. This publication is available from The office of Planning &amp; Research Division, Oklahoma DOT.</b>

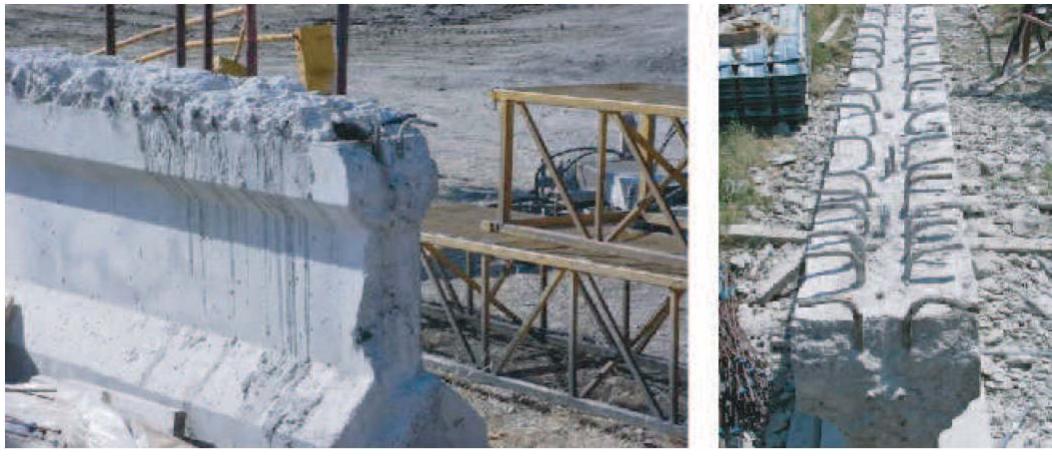
**Figure 3: The I-244 Bridge girder (a) before (taken by Mr. Richard Moon) and (b) after the slab was removed by Concrete Services Corporation.**

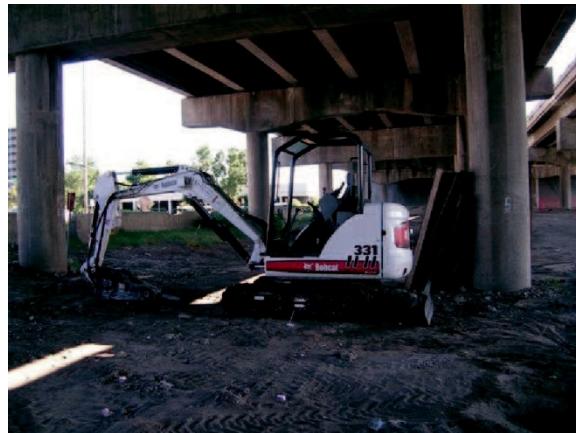
**Figure 4: Track hoe used to demolish the girder from the I-244 Bridge.**

As shown in Figure 10, numerous locations along the girder were visibly damaged once the girder was unloaded at Fears lab. Some damages are assumed to be from the removal of the girder from service. The slab was removed using a track hoe (see Figure 4) so the girder was more mobile. Some longitudinal cracks that propagate from the area of missing concrete suggest a large shear force similar to the hydraulic ram on the track hoe that removed the concrete. An inverse analysis in Chapter 4 will explore the effect of visible and invisible damages caused to the flexural stiffness of the girder for a more accurate estimation of the

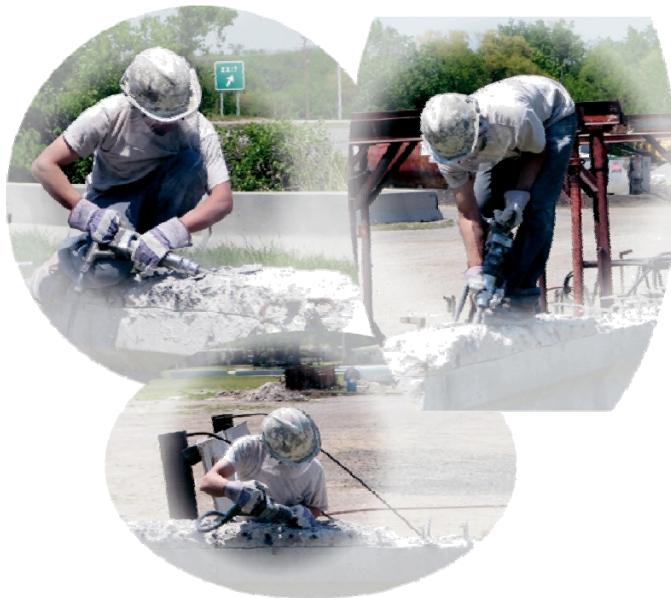
**Figure 5:** Augustine, a Concrete Services Corporation employee, removing remaining slab on April 21, 2006

Two field trips were made by this research team to Tulsa, OK for this girder during the project. Initially, the first trip to Tulsa was organized to view the condition of the girder and prepare the girder for transportation to the University of Oklahoma. During the first trip to Tulsa in April 2006, a local contractor, Concrete Services Corporation, was hired to remove the remaining slab from the top of the girder, the so-called "clean-up". See Figure 3 for the views before and after the clean-up. Once on site, major damages that had occurred to the girder were immediately noticed. These damages were resulted from the corrosion due to the lack of maintenance and perhaps, the removal process of the girder from the bridge. One end of the girder was severely corroded, therefore the girder was removed from the bridge. The track hoe used to demolish this and other girders from the bridge was documented in August 2005 and is shown in Figure 4. Given the original arrangement to abandon this girder, damages could easily occur in the demolition and shipping process. The clean-up process itself caused some visual damages, however they were not expected to be as severe as the above mentioned major damages as the personnel was supervised not to cause additional damage to the girder. A composite picture documenting the clean-up is presented in Figure 5.

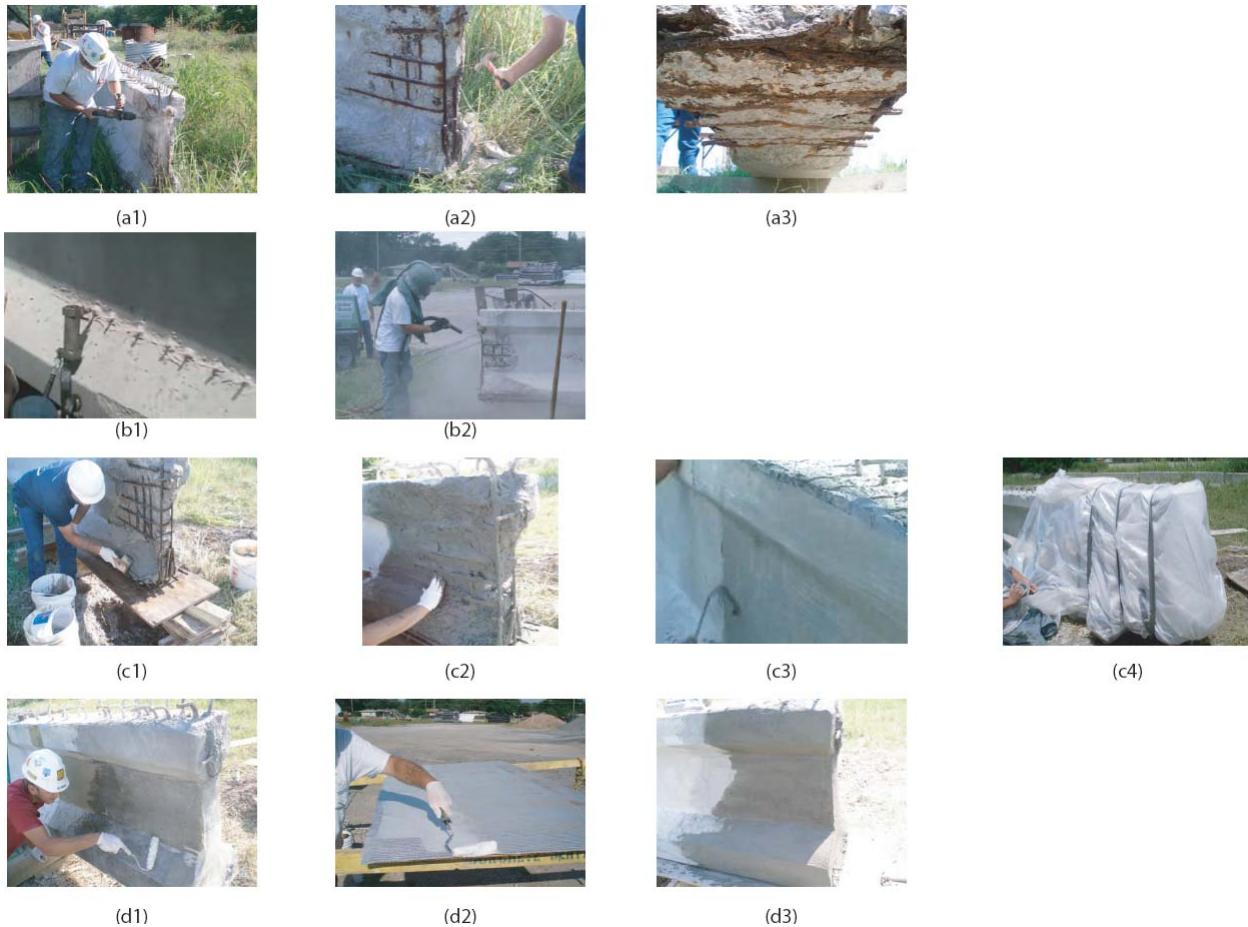
**Figure 7: Retrofitting process documented by Mr. Christopher Davis:** (a1) using a pneumatic drill to remove unsound concrete; (a2) using a standard hammer to remove unsound concrete so that more damage was not done; (a3) original view of damage to the bottom of the girder; (b1) sandblasting the surface; (b2) using a pressure injection epoxy to repair existing cracks; (c1) applying the initial coat of the wet mortar; (c2) applying the second coat of the intermediate mortar; (c3) the final mortar being the thickest and the repaired end finally shaped; (c4) the burlap sack that was used during curing; (d1) rolling on the epoxy to the girder prior to install the FRP wrap; (d2) impregnating the three-layer FRP wrap prior to installing it, and (d3) rolling the FRP wrap onto the girder to avoid air voids in the finished product.

The retrofitting process was documented in detail (Sandburg [2007]). Figure 7 shows a step-by-step view of the retrofitting process carried out by Concrete Services Corporation. The material was cured for 24 hours before the burlap was removed. To protect the retrofitted girder a UV coating was applied. When the contractor had finally finished the retrofitting the girder, transportation of the girder was organized.

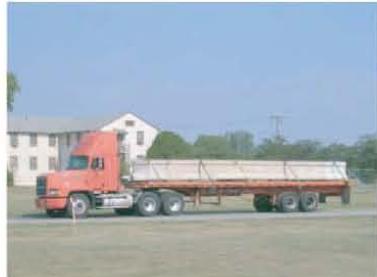
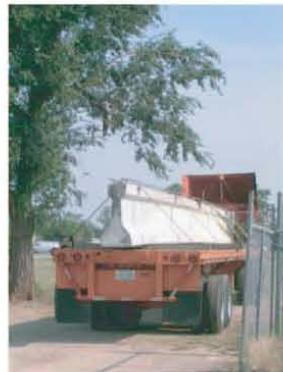
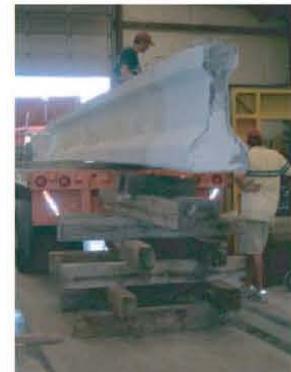
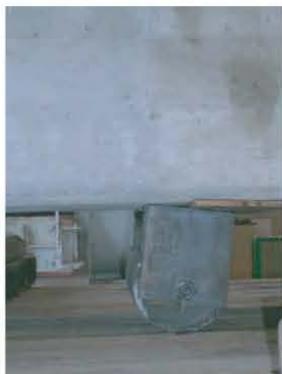
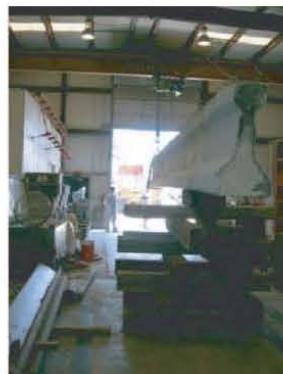
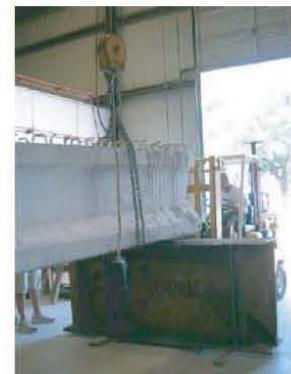
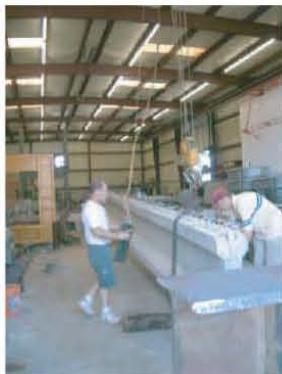
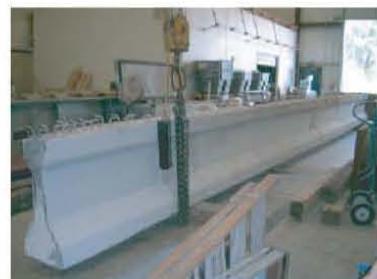
**Figure 8: Girder unloading at Fears Lab:** (a1) The girder on the delivery truck; (a2) the delivery truck backing into Fears lab; (a3) the cribbing built to support the girder while the truck left; (b1) the roller the girder was rolled on; (b2) the girder supported by the crane and the cribbing; (b3) the steel support the girder rested on after the truck left; (c1) the girder being lowered to the ground, and (c2) the girder being placed into the final location.

Schmitz, the lab manager. See Figure 8 for the snapshots of the process.

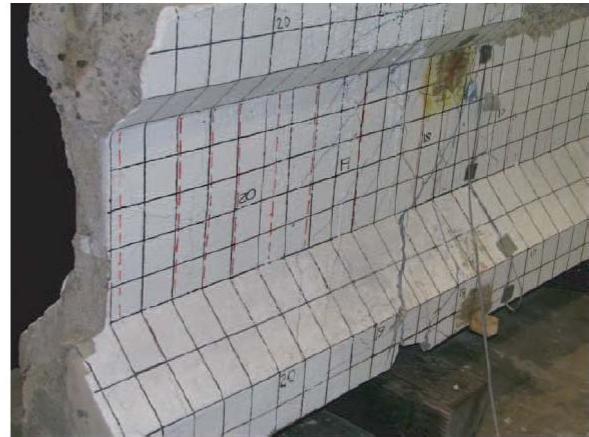
**Figure 12: Grid system placed on the I-244 Bridge girder, where (a) shows the origin, i.e., the hole pointing to the diaphragm's location (circled), and (b) shows the grid system drawn by Mr. Aaron Landrum using Sharpie markers and the stirrups located by Mr. Krisda Piyawat using a pacometer borrowed from ODOT.**

Once the girder was under the loading frame and out of the main traffic areas at Fears lab, visible damages on the girder, shown in Figure 10, were patched with a commercial repair concrete. When the repairs were complete and dry, the girder was painted white for further testing. Following the decision of the origin, other testing preparations include drawing grid lines of 3" by 3" onto the two sides of the girder throughout the span by Mr. Aaron Landrum using Sharpie markers and using a pacometer borrowed from the ODOT to scan the location of some stirrups and bend-up locations of the draped strands by Mr. Krisda Piyawat. Figure 12 contains photos of the grid system placed on the girder, which enables an efficient documentation of cracks in further testing.

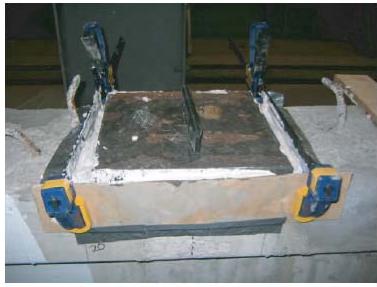
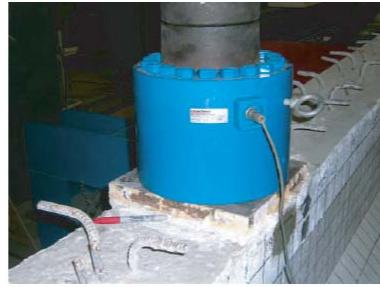
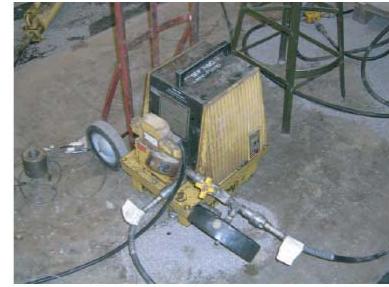
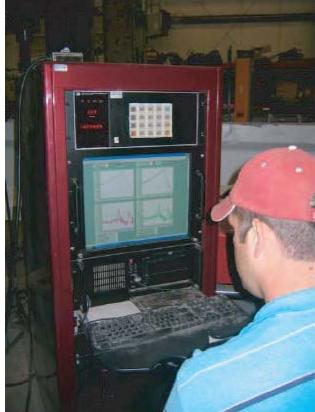
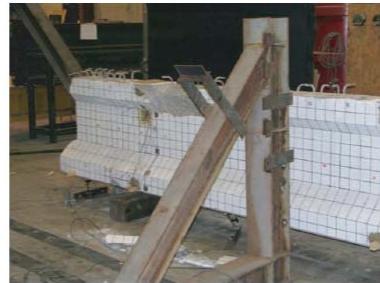
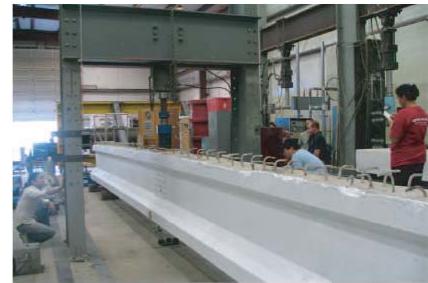
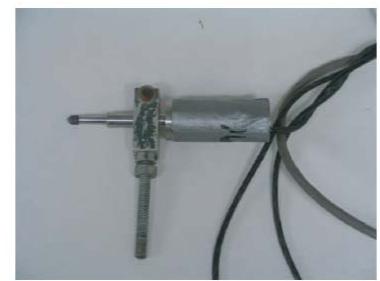
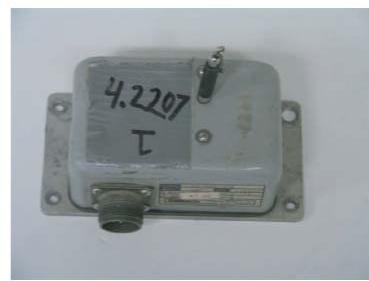
**Figure 15: Instrumentation used in testing the original I-244 Bridge girder:** (a1) Loading plate; (a2) one of the load cells used to determine the load applied to the girder; (a3) hydraulic pump to apply the load; (b1) front panel of the DAQ system; (b2) bracing used for stability; (b3) loading frame used for flexural stiffness and shear tests; (c1) and (c 2) LVDTs, and (c3) wire potentiometers.

To gain accurate results, a reference system and grid lines were prepared beforehand (see Section 2.2.2). In addition, a series of details were taken care of under the guidance of Mr. Michael Schmitz. These include creating a smoothing loading surface using a 1' by 1' steel plate setting on Hydro-Stone (see Figure 15(a1)). The same method was applied to all flexural stiffness and shear tests. Two load cells (see Fig. 15(a2)), six linear variable displacement transducers (LVDTs, see Fig. 15(c1) and (c2)), and several strain gauges were used in flexural stiffness tests. Troubleshooting strain gauges was carried out separately, while the calibration was documented in Sandburg [2007]. In all tests, the difference in the readings of the two load cells were within 1%; the readings of the two load cells were thus averaged in the results (Sandburg [2007]). The data acquisition system (DAQ) used throughout the experimental study in this project (see Fig. 15(b1)) was developed by Dr. Christopher Ramseyer. The LabVIEW program files used in this project were prepared by utilizing the template files provided by Dr. Ramseyer.
