PERFORMANCE OF ULTRA-THIN WHITETOPPING (UTW) IN OKLAHOMA

FINAL REPORT ~ FHWA-OK-10-05
ODOT SP&R ITEM NUMBER 2222

TYLER LEY
HARI ROTITHOR
OKLAHOMA STATE UNIVERSITY
CIVIL AND ENVIRONMENTAL ENGINEERING
207 ENGINEERING SOUTH
STILLWATER, OKLAHOMA 74078

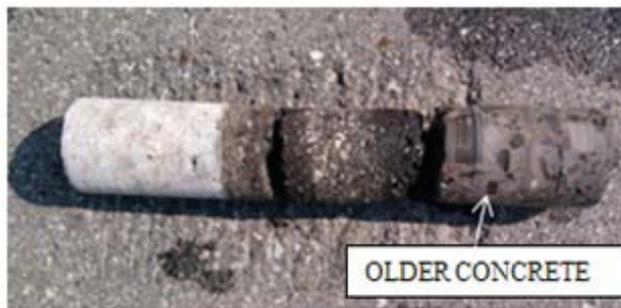
Coring gives the details about the depth of the different layers present below the overlay. The detailed information about the different layers gives a better understanding about the present and future performance of the overlay. It also provides the opportunity to run tests like dynamic cone penetrometer to determine the foundation properties of the subbase layer. In this project DCP tests were run at all the coring locations. However, different types of soil conditions were observed. So it was hard to decide the exact expressions to be used for finding the bearing capacity. Also it was thought that the number of DCP tests was less for such lengths of the overlays. However, a fair estimate of modulus of rupture has been given in Appendix – A for three overlays in McAlester area. Because of the violent nature of the coring it is hard to comment on the bond between concrete and asphalt. It was common for debonding to be observed between the two layers. Fig. 2.4 shows a typical core photo.

Figure 2.4 – A typical core from an Oklahoma whitetopping.

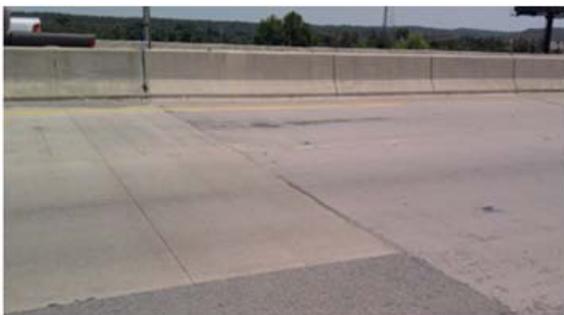
Figure 2.12 – The overlay terminates at a bridge and does not show any distress.

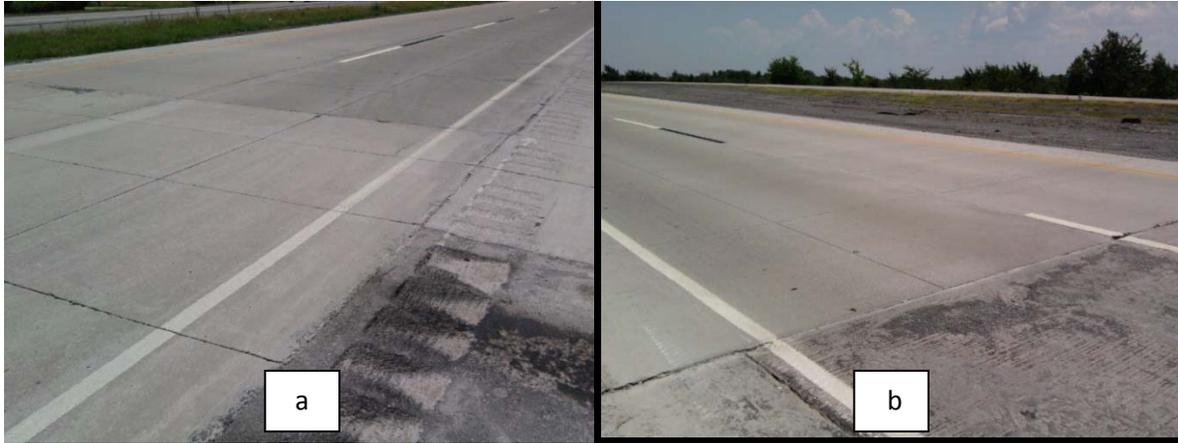
These overlays, being new, are in good shape and have not shown any notable sign of distress. The figures below show the good condition of the overlays. Figures 2.16 a and b show the start and the end of the south bound overlay. The good condition of the overlays is seen in all the photographs.

Figure 2.16 - Photo a showing start and photo b showing end of the south bound overlay.

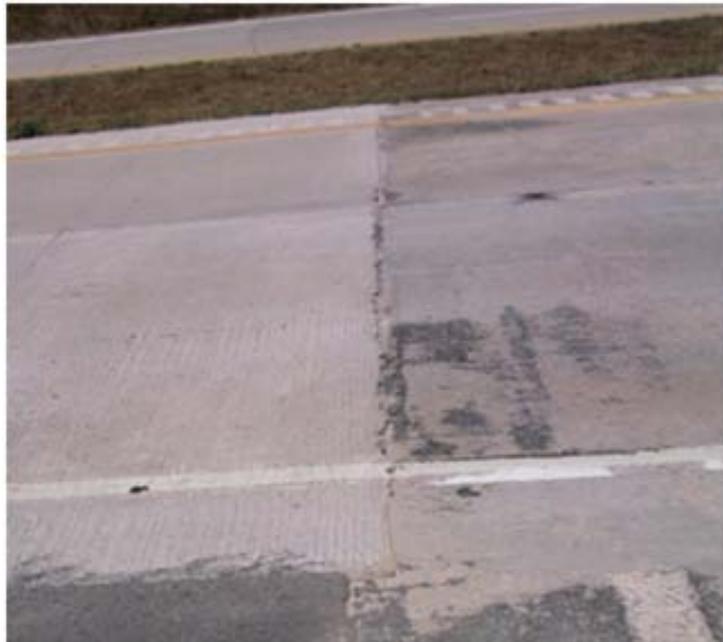
Figure 2.20 – The interface of the overlay and the adjacent pavement is in good condition.

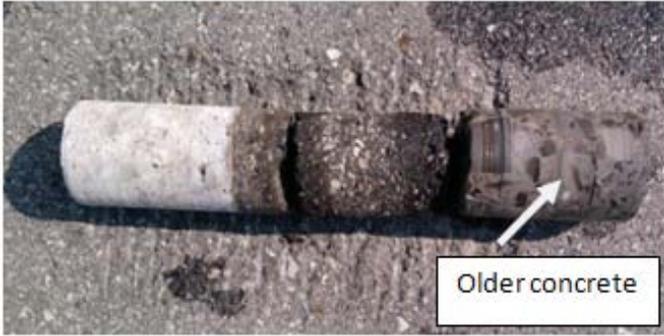
Coring on the Chockie Overlay showed that the asphalt that was placed on top of an old concrete layer. The asphalt layer was 8" to 9" in the driving lane and 10" to 12" in the passing lane. The constant depth of the old concrete pavement was 6". Four cores were taken at the locations 2 and 7 in the passing lane and 3 and 9 in the driving lane from Table 2.11. Figure 2.27 shows the core at location 9.

Figure 2.27 – Core from location 9.

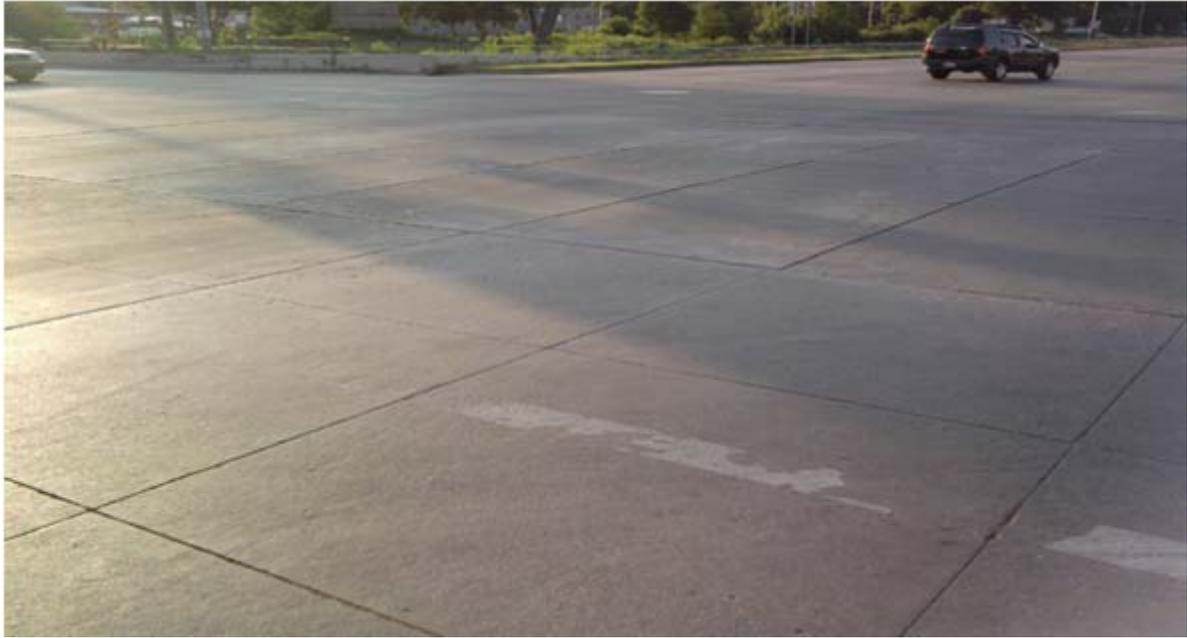
Fig. 2.31 is a photo taken from the edge of the gas station towards the north-west. The panels of the intersection seen in this photo look excellent. There was negligible amount of distress on this side of the intersection. Also the approach from south as shown in Fig. 2.32 does not show any damage. One explanation for this is that there was no elevation difference between the asphalt and concrete overlay. The panels, as seen in Fig. 2.33, on the approach lanes from south to the intersection on US – 177 look in good condition. Again Fig. 2.34 shows the same good conditions of the panels on the approach from the north to the intersection on US – 177. The area shown in Fig. 2.35 is the approach on US – 177 from the north side. Fig. 2.35 supports the hypothesis that if there is no elevation difference between the asphalt pavement and the concrete overlay, the initial panels will show good performance.

Figure 2.31 - Intersection as seen from the edge of gas station towards north-west.

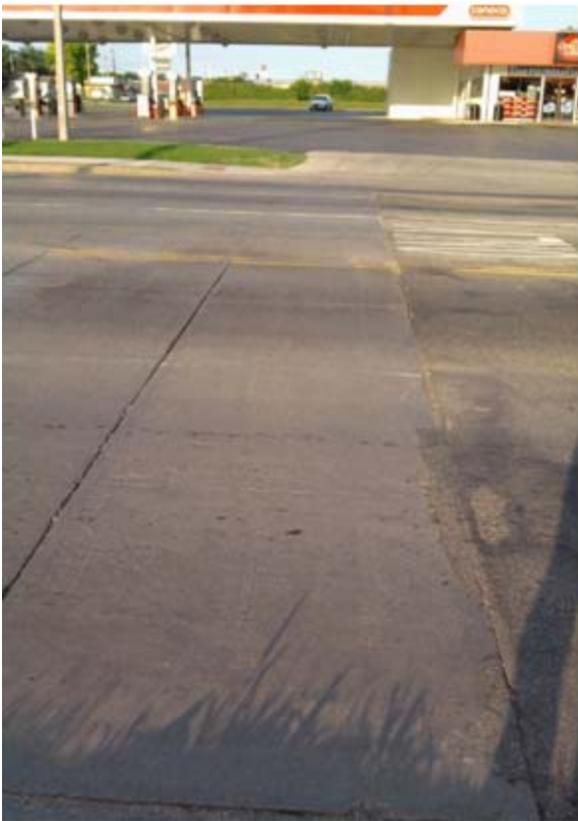
Figure 2.32 - Approach on US 177 from south showing excellent condition of initial panels.

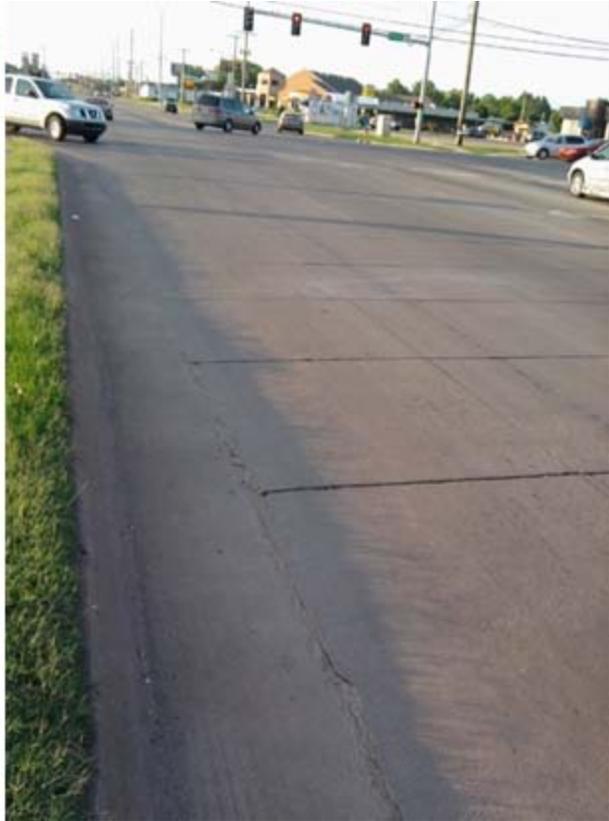
Figure 2.33 - Excellent condition of panels on US 177 from the south.

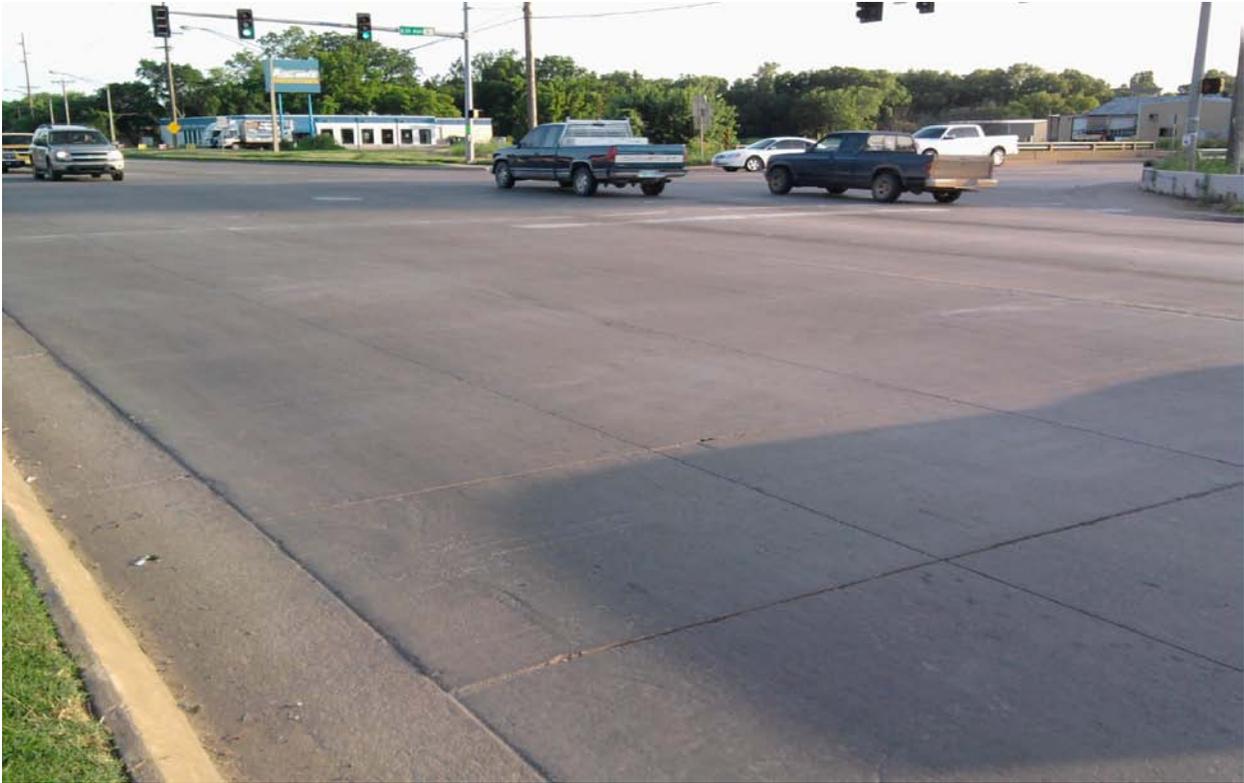
Figure 2.34 - Photo of intersection seen on US 177 towards south-west showing excellent condition of overlay.

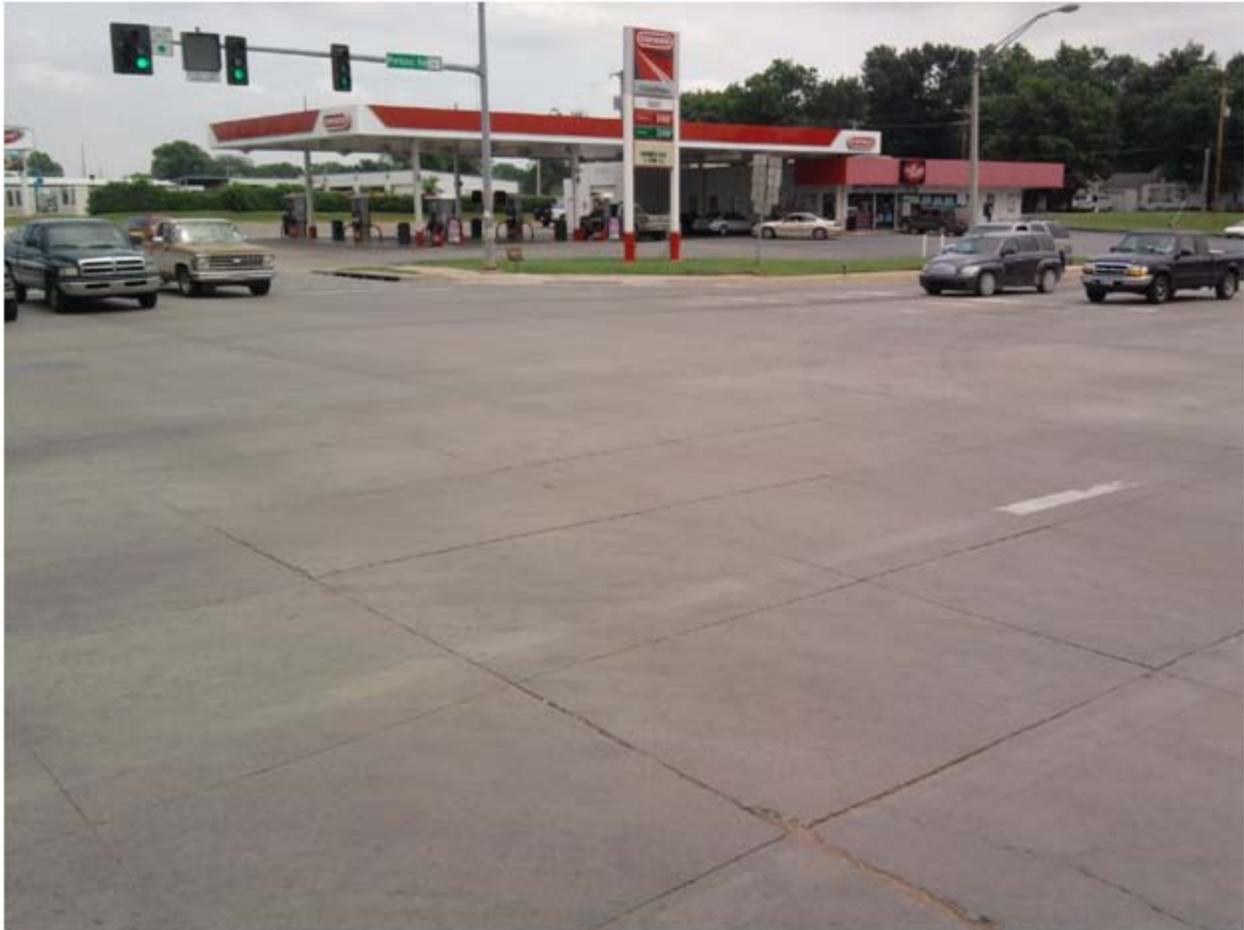
However, overall condition of the overlay in the intersection looked satisfactory as shown in Fig. 2.45.

Figure 2.45 - Overview of the intersection.

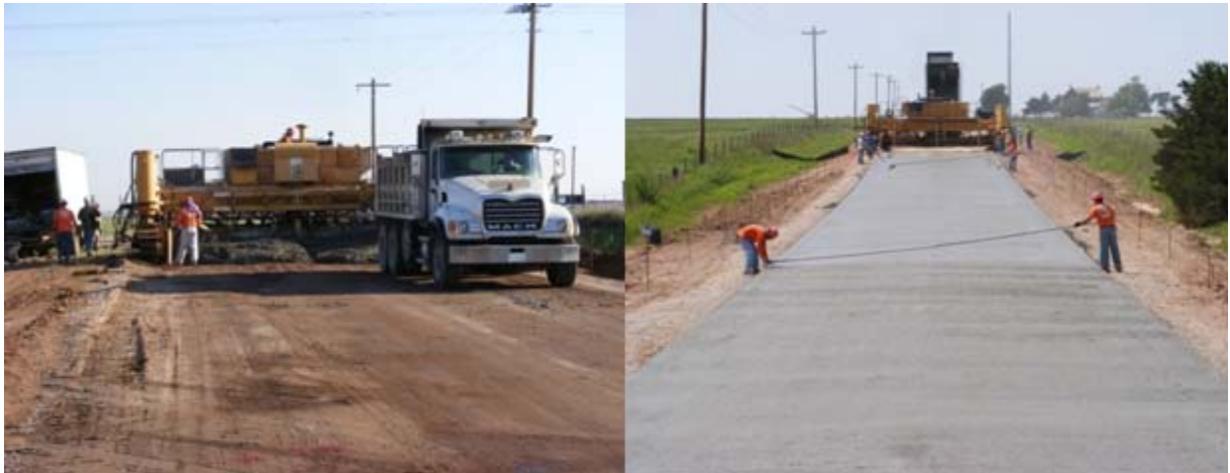
Figure 2.48 - Photos show the construction of the overlay.

- 3) During the construction the old asphalt pavement surface was not milled and may not have been accurately cleaned. This can be seen in Fig. 2.48. Therefore, it is possible that the asphalt and concrete may not have a good bond. If de-bonding occurs then one would expect a significant decrease in performance for the overlay.

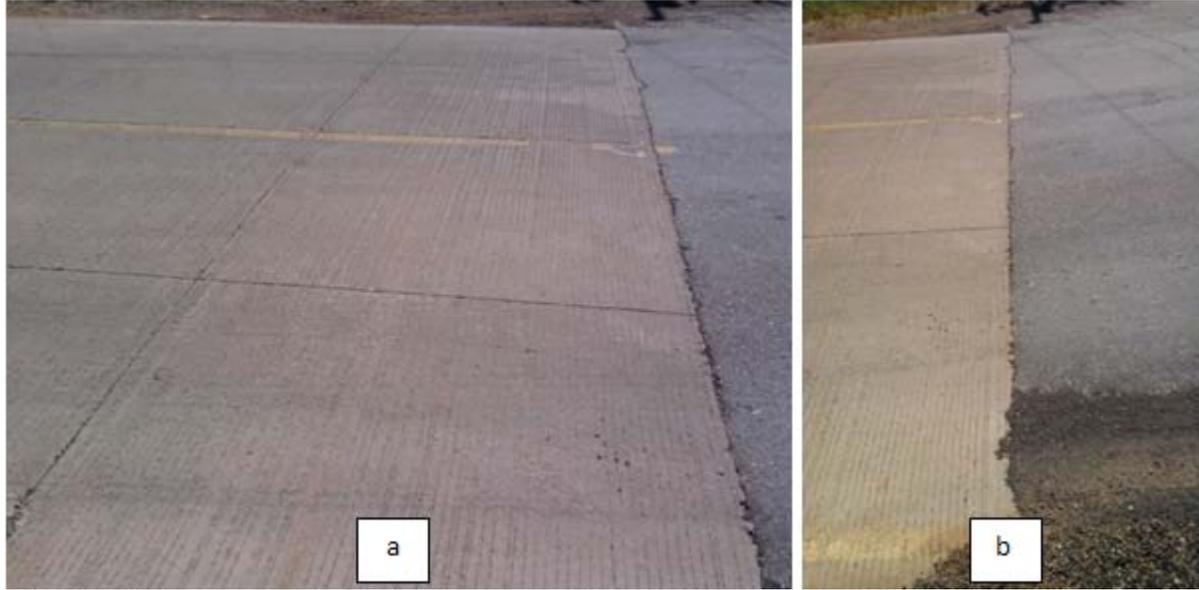
Figs 2.50 & 2.51 show the beginning of the overlay on its south side. The initial panels, which from previous experiences are the most critical, look un-cracked.

Figure 2.50 - Photos a and b show approach panels in un-distressed condition. Elevation difference between leaving asphalt pavement and approaching concrete panels is almost zero.

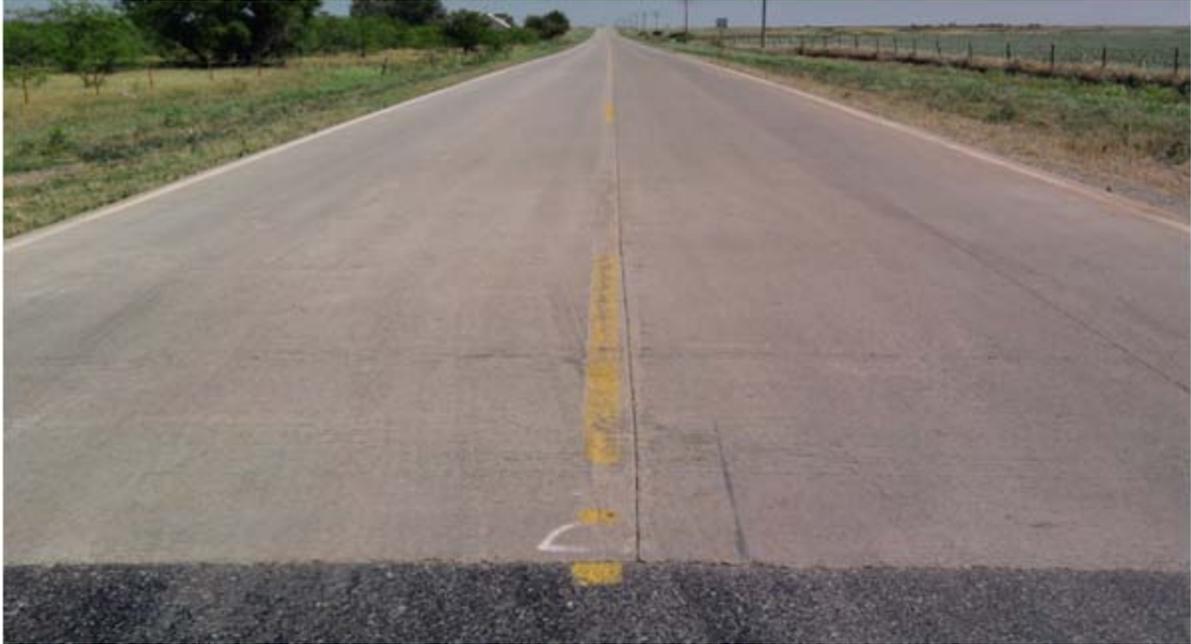
Figure 2.51 - Photo shows the overlay from south direction (looking towards north).

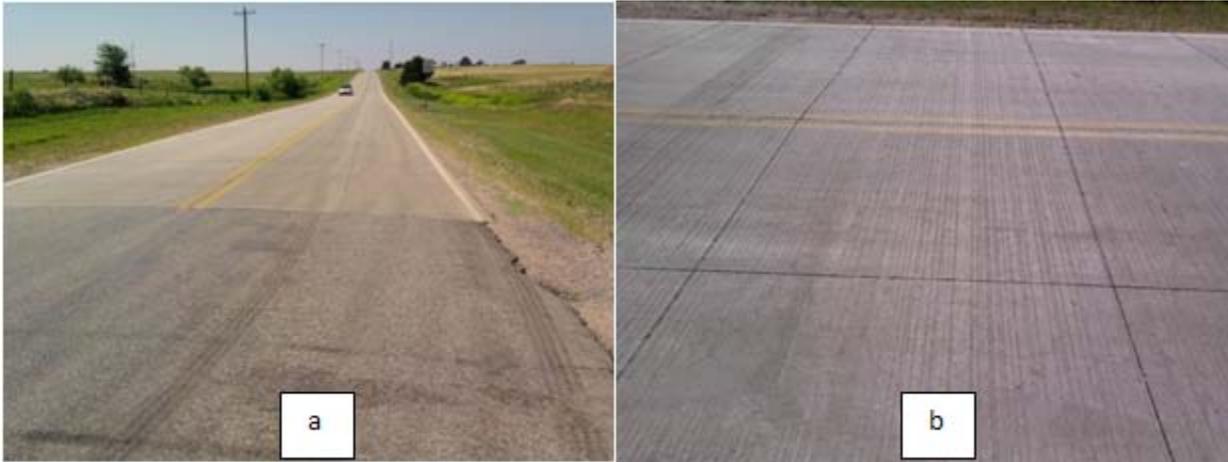
Fig. 2.52 shows the condition of the overlay where it ends on the north side. The elevation difference in between concrete and asphalt pavements was thought to be insignificant. The good condition of the initial panels suggests that if the same elevation for approach and leave pavements is maintained, the initial panels on the overlay are less likely to fail assuming that there is good bond between the concrete and the underlying asphalt.

Figure 2.52 - North end of overlay. Photo a is taken looking towards south direction. Photo b is seven panel series from the end of the overlay.

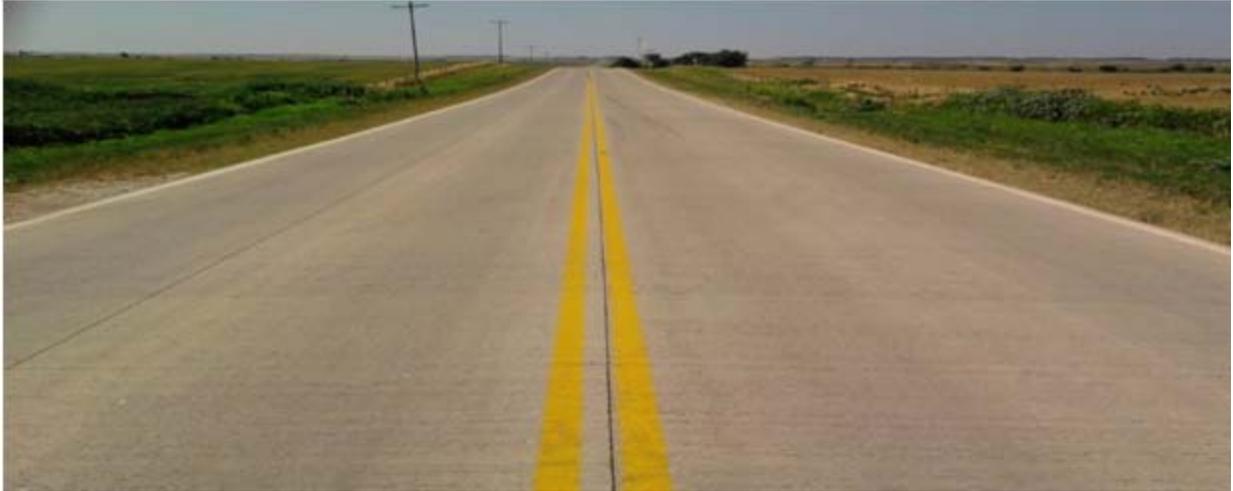
Figure 2.53 - Photo showing the excellent condition of the overlay.

The overall condition of the thin white topping is excellent as shown in Fig. 2.53. The research team did not notice any longitudinal cracks, transverse cracks, fatigue distress or pop outs.
