BEAM FRAMING REPAIR PLAN

S.H. 74 OVER I-35 McCLAIN CO.

DESIGN	GDD		OKLAHOMA DEPARTMENT OF TRANSPORTATION
DRAWN	ZTF		
CHECKED	JTK		
APPROVED			
SQUAD	MacArthur		
BEAM FRAMING REPAIR PLAN			
STATE JOB NO. 29572(04)			SHEET NO. 19

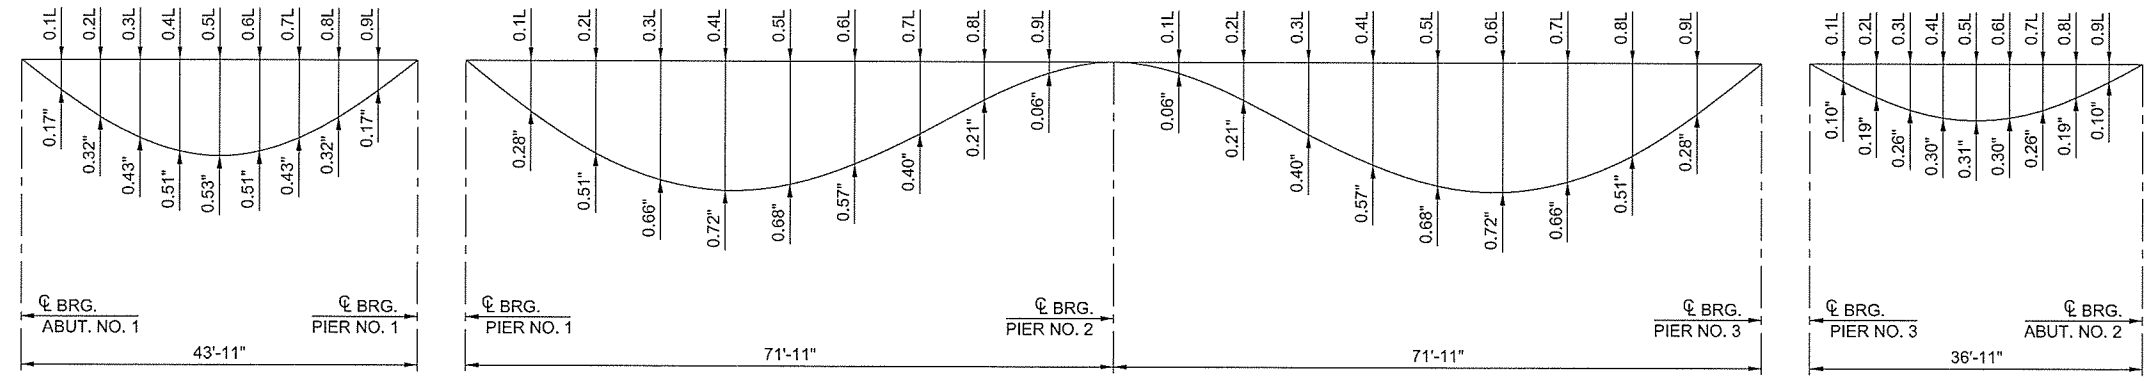
DEAD LOAD DEFLECTION DIAGRAM

THE DEAD LOAD DEFLECTION SHOWN AT THE TENTH POINTS ARE DEFLECTIONS DUE TO DECK SLAB + HAUNCH + CONCRETE TRAFFIC RAIL. DOES NOT INCLUDE THE GIRDER WEIGHT OR WEIGHT OF THE DIAPHRAGMS.
