BRIDGE "B" SH-2 OVER KIAMICHI RIVER	PUSHMATAHA COUNTY	Design	N/A	N/A
GENERAL PLAN, TYPICAL SECTION, AND DETAILS OF JOINT REHABILITATION (BRIDGE "B")		Detail	DPG	5/16
		Check	TEE	6/16
STATE OF OKLAHOMA		Squad:	HENSFLEY	
DEPARTMENT OF TRANSPORTATION		Engr:	DEFRANCO	
JOB/PIECE NO. 31697(04)		SHEET NO.	B002

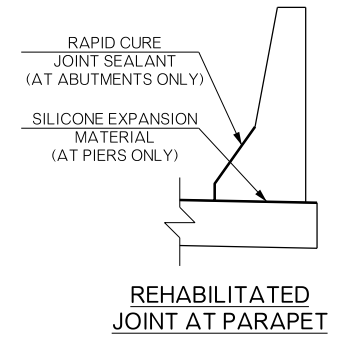
REHABILITATED JOINT AT PARAPET

NOTE: AT ABUTMENTS, PLACE RAPID CURE JOINT SEALANT 1'-0" UP THE TRAFFIC FACE OF PARAPET AS SHOWN WITH A HEAVY LINE. AT PIERS, PLACE SILICONE EXPANSION MATERIAL CONTINUOUSLY ALONG THE JOINT THROUGH THE PARAPET TO THE EDGE OF THE DECK.

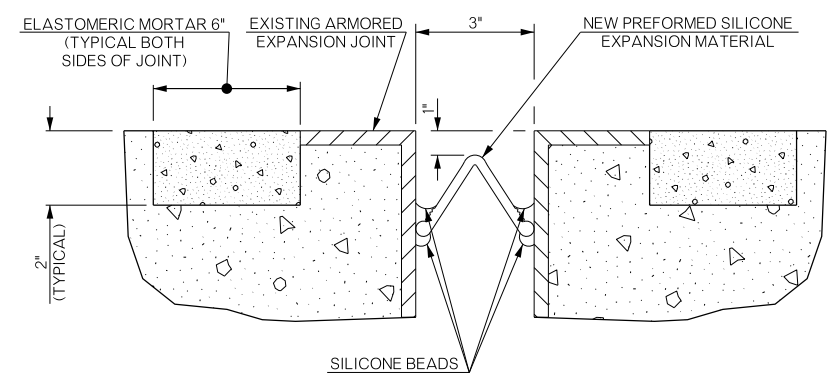
REHABILITATED EXPANSION JOINT AT PIERS

① SAW TO THE DEPTH SHOWN TO PROVIDE CLEAN STRAIGHT SURFACES.
